# Stormwater Scoping Study

## Castleton | Staso Road

Castleton TAP TA 19(3) Staso Road Stormwater Scoping Study

MSK Engineers

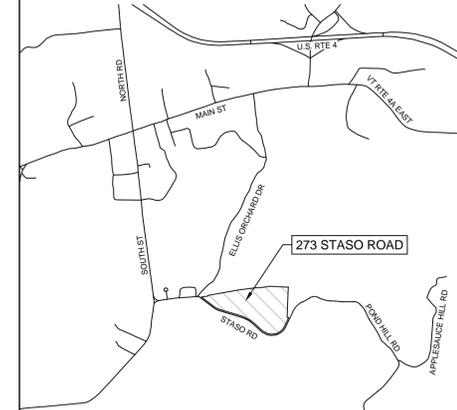
# FIGURE 1: Existing Conditions

The Town of Castleton's 29-acre property along Staso Road has many current active uses which include the Town Highway Garage, the Town's Transfer Station, a salt and sand storage area, and a sand and gravel quarry (see **Figure 1: Existing Conditions**). Each of these uses contribute to stormwater runoff in a southerly direction toward Staso Road and eventually to Pond Hill Brook via two cross-culverts under Staso Road. The Town is concerned about its properties impacts on water quality in the brook. While the Town has some flexibility on the property for designing and siting stormwater drainage and treatment practices, as well as finding an appropriate location for the salt and sand shed, the parcel is subject to the VTDEC Stormwater Program's 3-acre rule.

The property is a mixture of forested and developed land. The site is a source of aggregate for Town projects, hence much of the local topography has been altered due to these extraction activities. Generally, the site slopes steeply down from north to south with a plateau at approximately the middle of the site. The plateau serves as a storage area for Town equipment and staging area for the mining operations. The southern portion of the site below the plateau is bounded by Staso Road and contains the Town garage and pole barn to the west, transfer station in the middle, and current salt shed to the east. An access drive connects the town garage to the upper plateau with a second drive connecting the upper plateau to the transfer station below. The sand and gravel extraction area located on the upper plateau is generally in-sloped with runoff accumulating at the toe of the extraction slope and eventually infiltrating to groundwater. Portions of the extraction area drain towards the transfer station and towards the Town Garage along the access roads. The southeast corner of the extraction area drains down a steep slope into the forested wetland. The town garage and transfer station drain to the swale along Staso Road to cross-culverts discharging directly to Pond Hill Brook. Runoff from the existing sand and salt storage area drains to a ditch that is connected to the swale along Staso Road via a culvert under the transfer station entrance. However, the swale and culvert inlet are currently filled with sediment, causing stormwater to overflow to the roadway. A continuous graded berm along the road edge causes runoff to continue along the road, bypassing the cross-culvert, continuing west to the transfer station exit.

The Town has recently installed two stormwater treatment features for the transfer station. The Town and Poultney Mettowee Conservation District installed a drywell/forebay and surface infiltration feature to treat runoff from a portion of the transfer station inlet in 2018. The Town also installed a stone lined ditch and a pre-treatment forebay to collect runoff from the upper portion of the transfer station. The forebay currently discharges to the roadside swale and will be connected to the proposed gravel wetland system north of the transfer station exit.

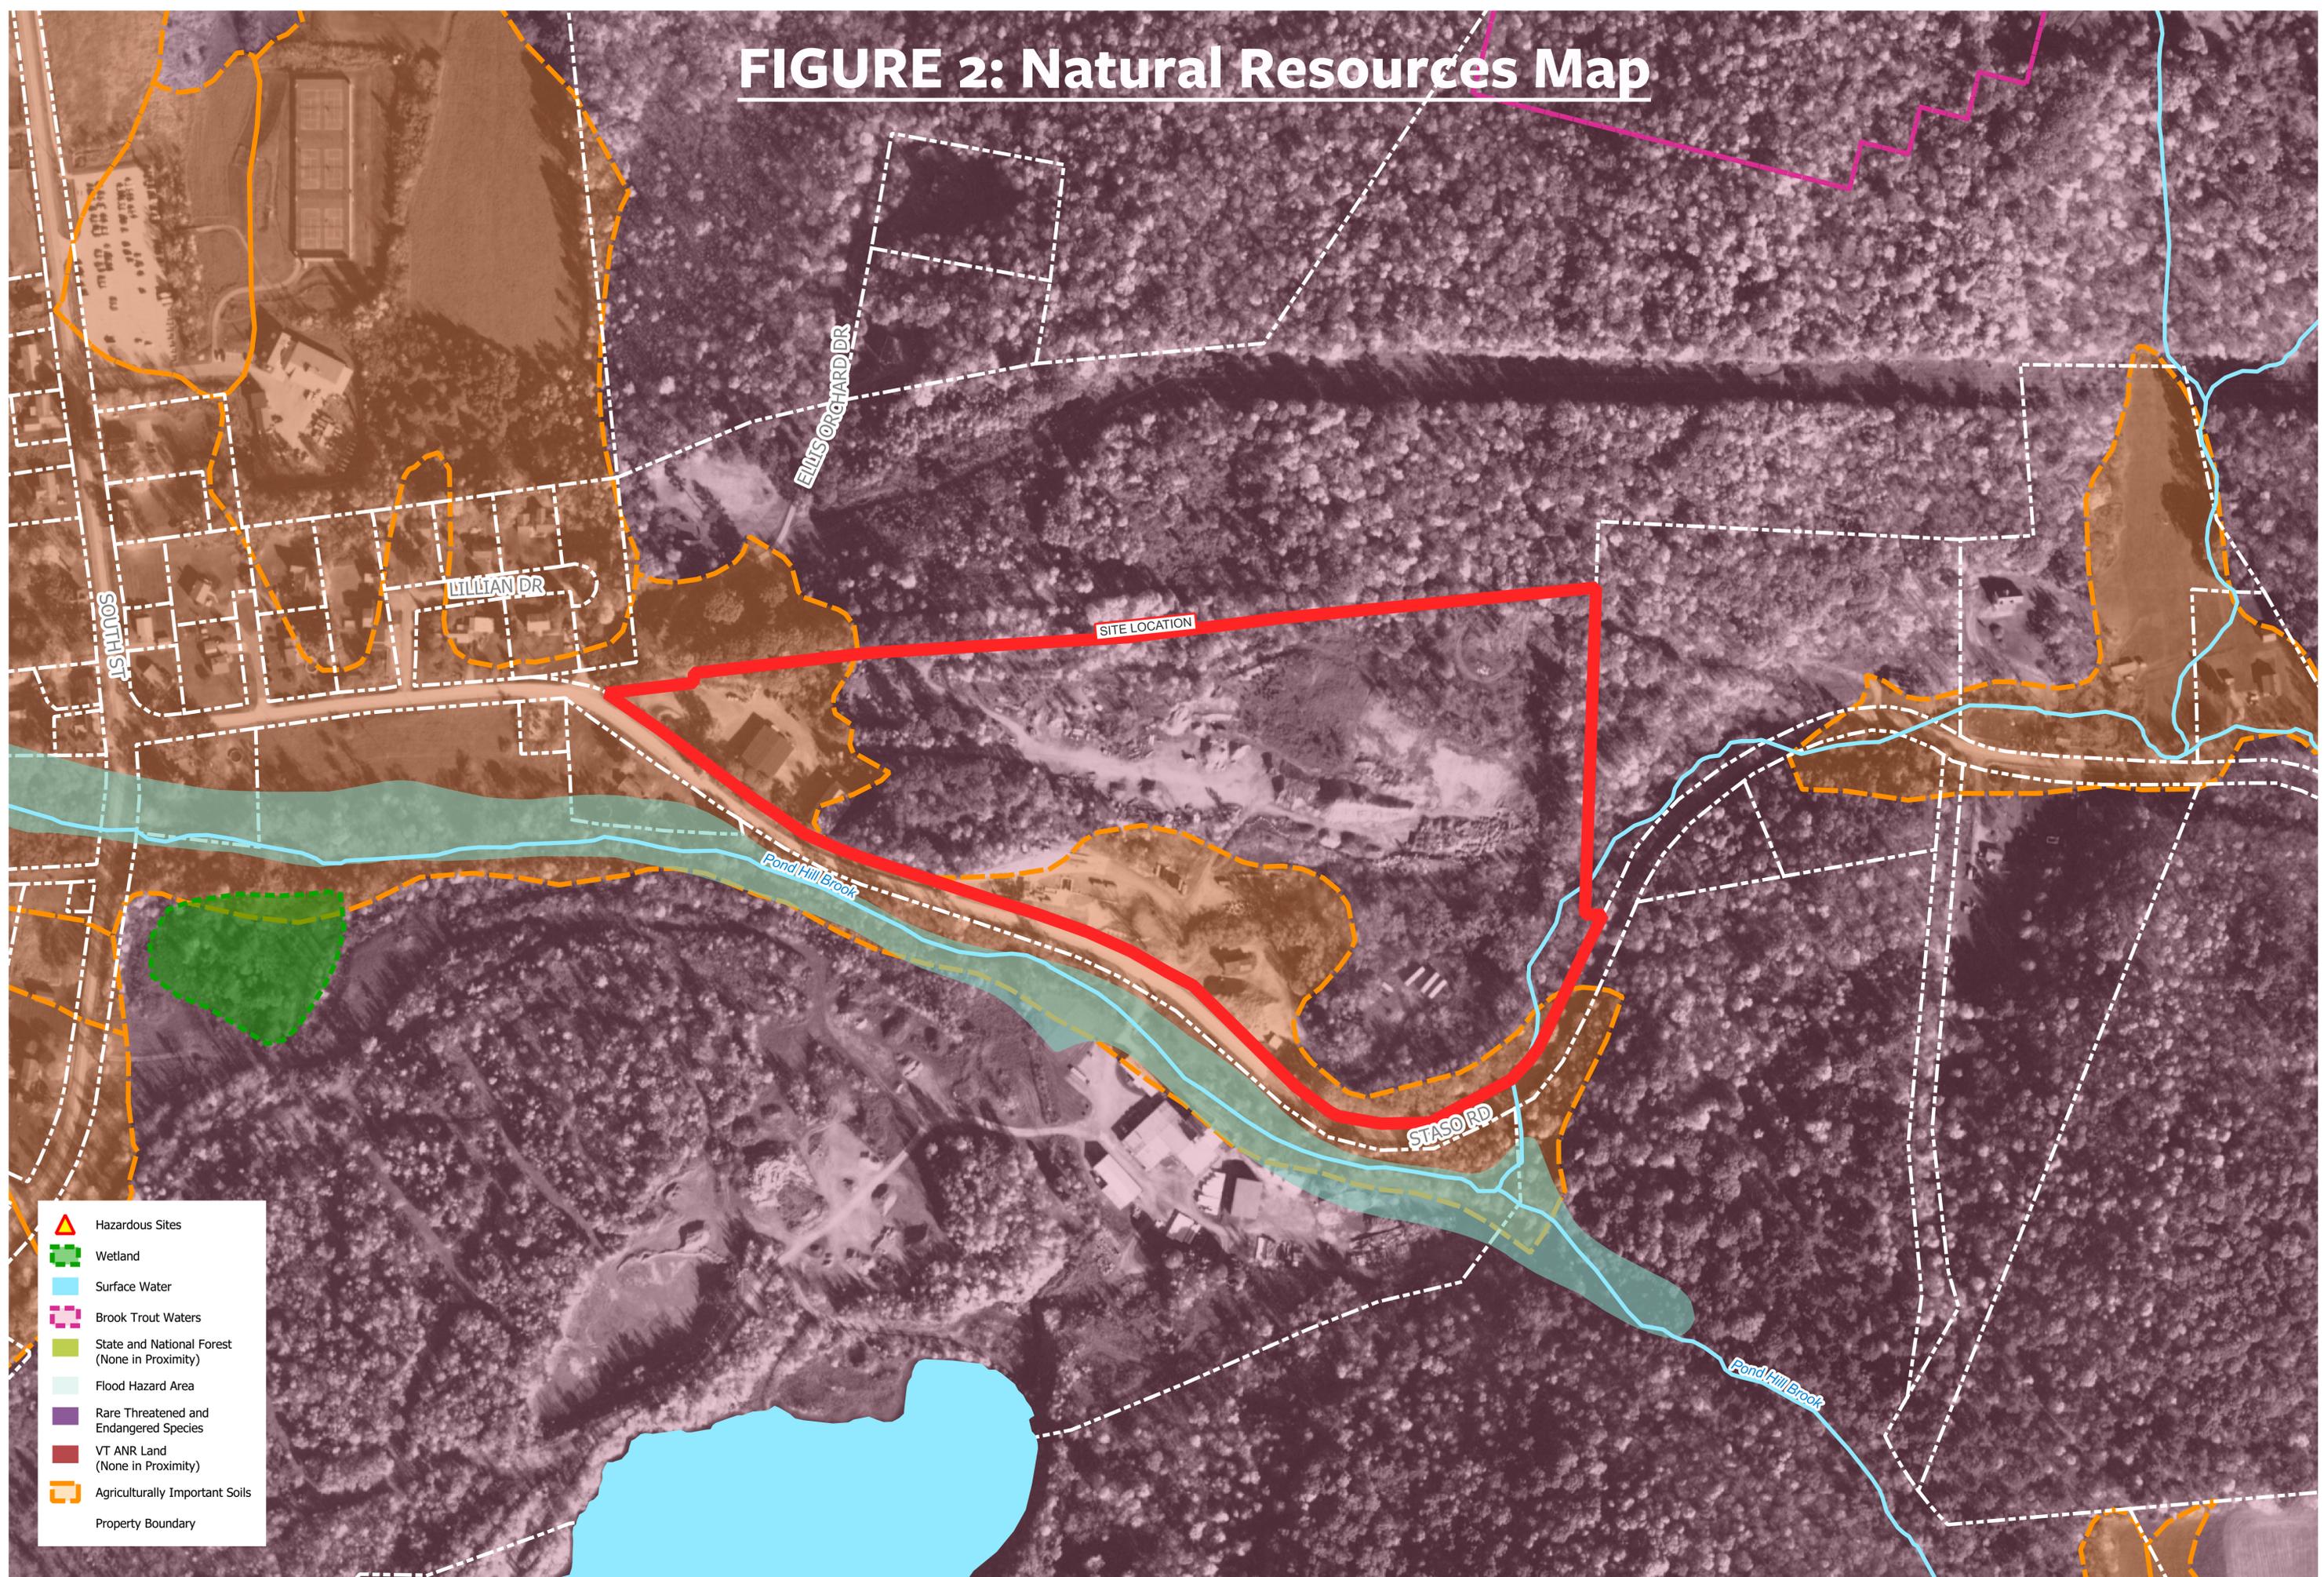
# FIGURE 2: Natural Resources Map

- Hazardous Sites
- Wetland
- Surface Water
- Brook Trout Waters
- State and National Forest (None in Proximity)
- Flood Hazard Area
- Rare Threatened and Endangered Species
- VT ANR Land (None in Proximity)
- Agriculturally Important Soils
- Property Boundary

**Primary agricultural soils:** While portions of the project are located in primary agricultural soils, these portions have been previously developed. The selected alternative does not negatively impact primary agricultural soils that have not been previously disturbed as this project currently has a Act 250 Land use permit. During the Act 250 permitting process the permittee will confirm previous disturbance with the Agency of Agriculture and mitigation is not anticipated.

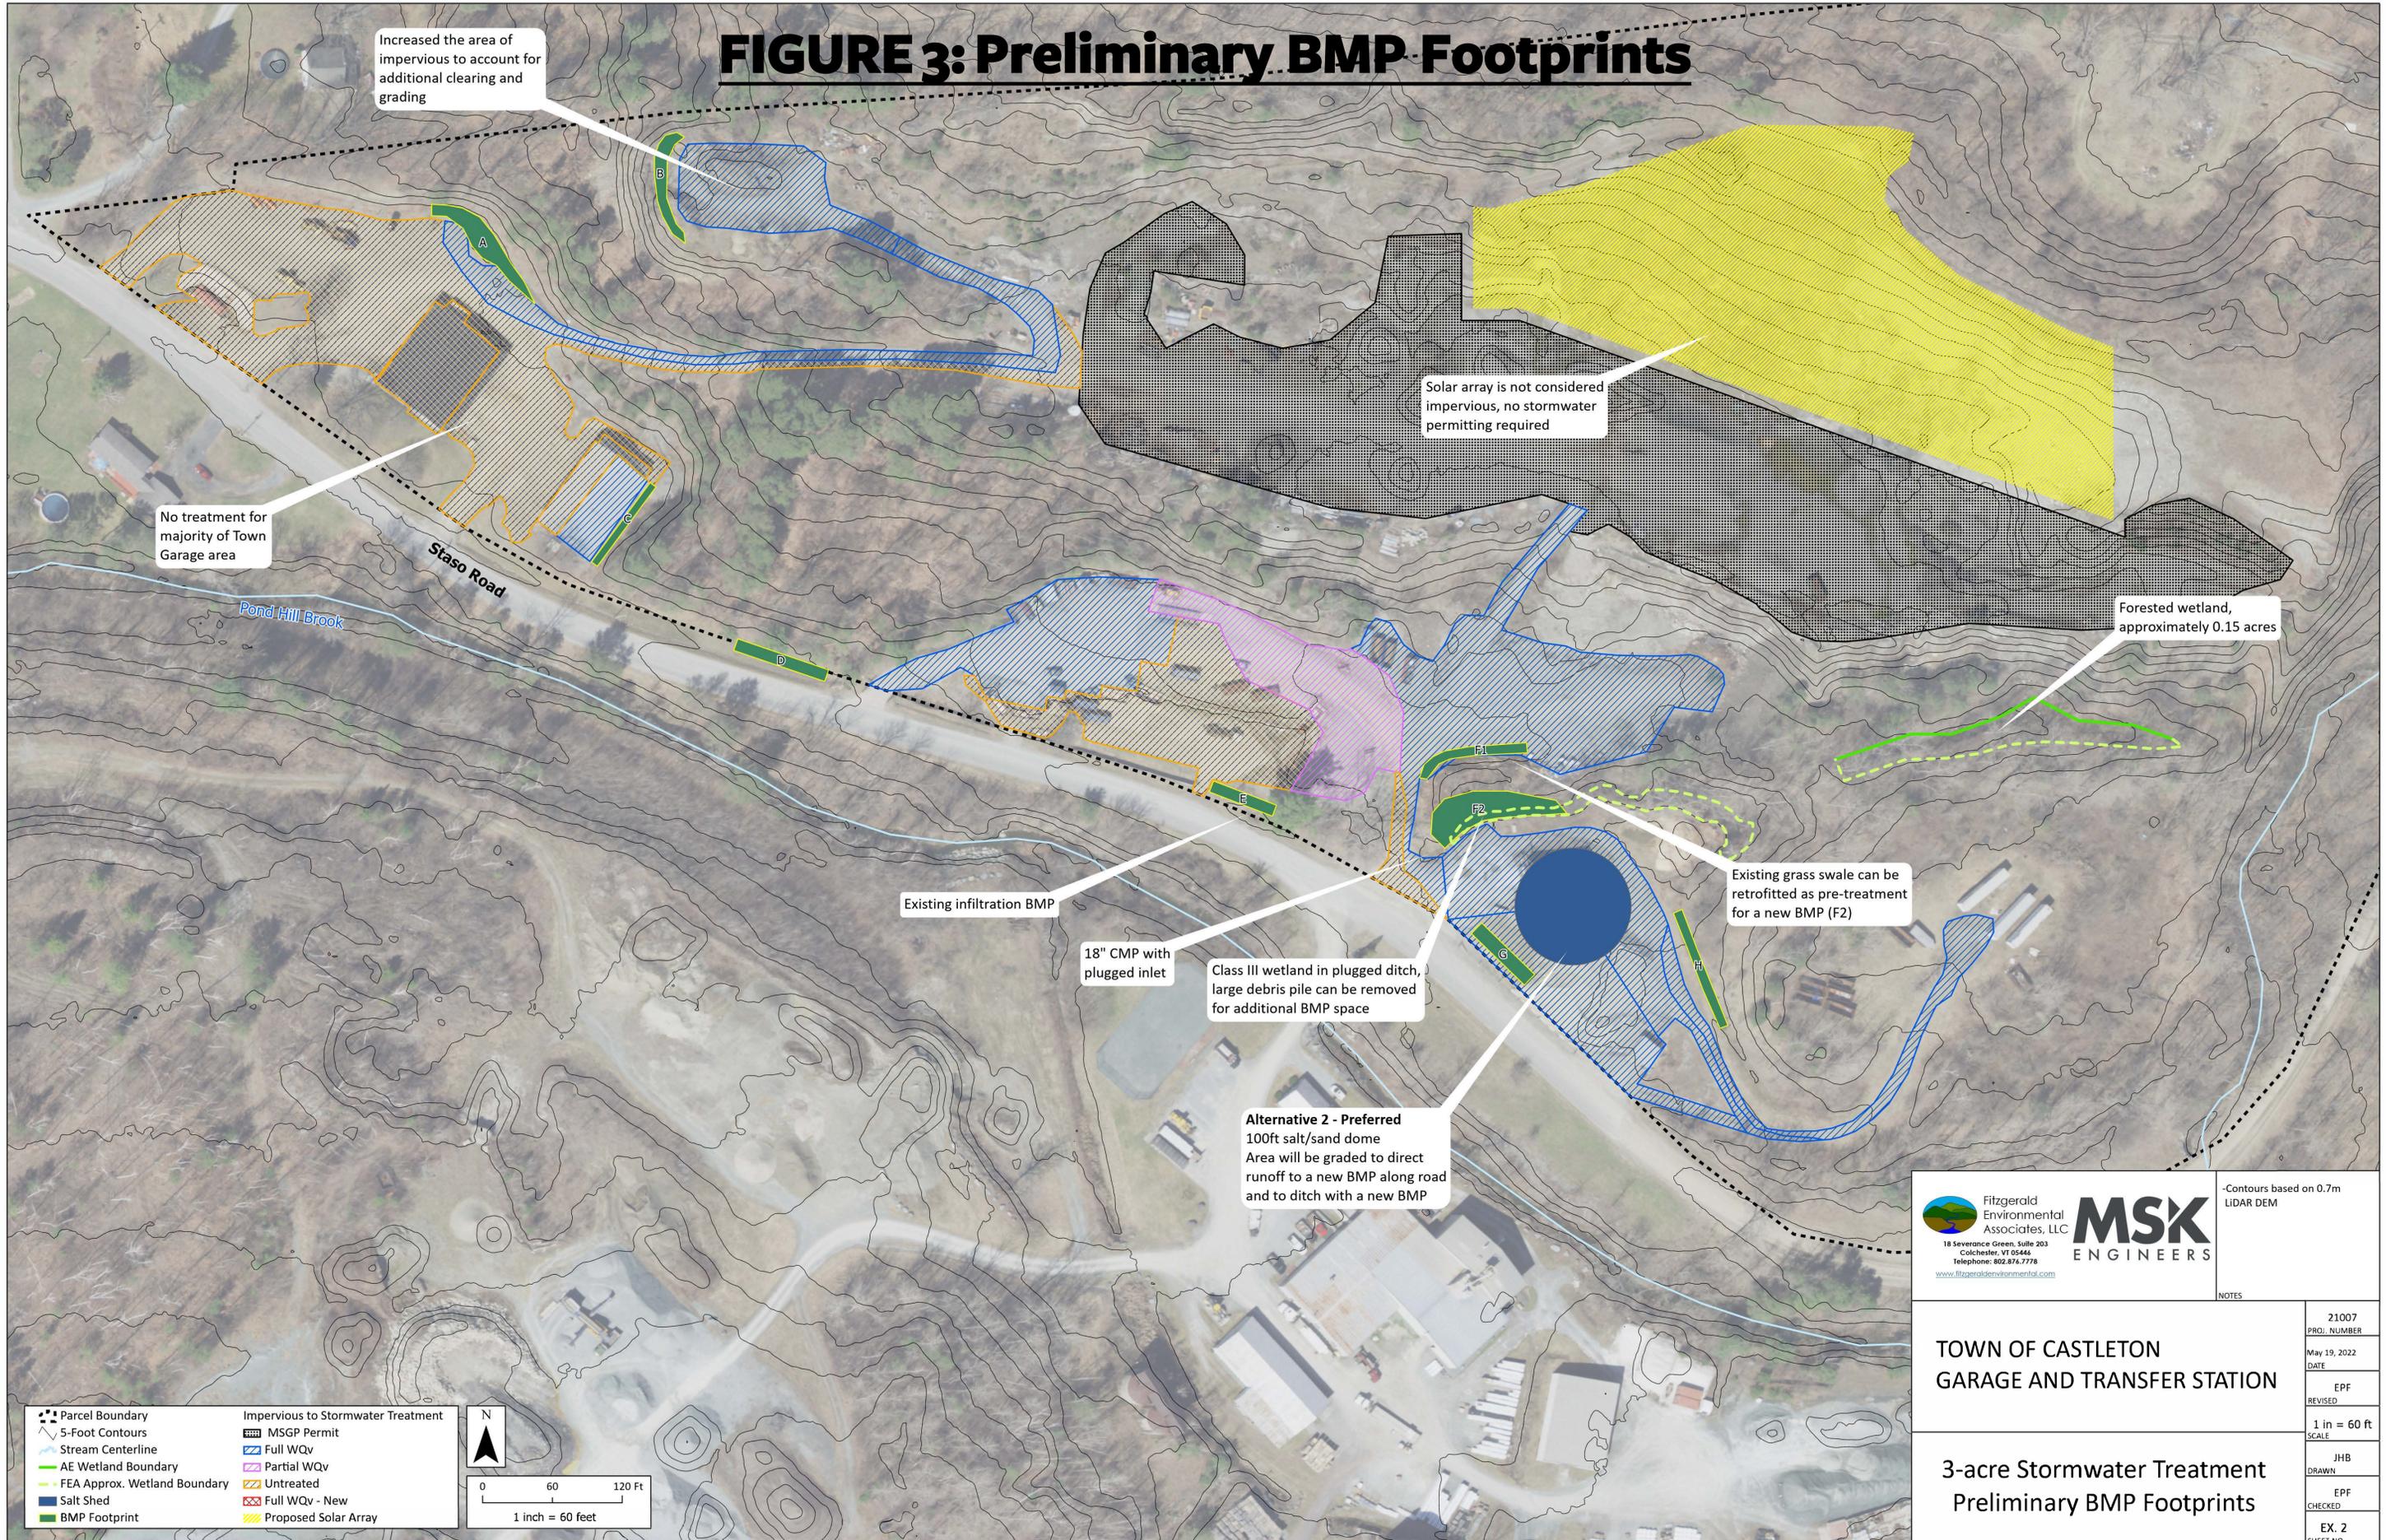
# FIGURE 3: Preliminary BMP Footprints

Increased the area of impervious to account for additional clearing and grading

No treatment for majority of Town Garage area

Existing infiltration BMP

The recently constructed infiltration feature near the transfer station entrance will count towards the 9050 permit requirements. This feature provides approximately 600cf of treatment volume, representing 7% of the permit requirement for the property. Additional stormwater treatment features totaling approximately 7,600 cf of treatment volume will be required on the property to meet the 9050 permit. **Table 1** below shows a preliminary layout of treatment features that will meet the required stormwater treatment volume.

BMP	Description	Drainage Area (ac)	Impervious Acres	Pervious Acres	% Impervious	WQv (cf)	Potential Treatment (cf)
A	Proposed - potential infiltration feature along edge of parking area behind garage	1.2	0.24	0.96	0.20	1,002	1,002
B	Proposed - infiltration feature along edge of clearing for upper storage area	0.75	0.23	0.52	0.31	888	888
C	Proposed - infiltration for eastern portion of pole barn only	0.07	0.07	0	1.00	241	241
D	Proposed - gravel wetland along road above ditch Pre-treatment from existing forebay	1	0.36	0.64	0.36	1,358	1,360
E	Existing infiltration swale with pre-treatment catch basin	0.45	0.32	0.13	0.71	1,127	600
F1	Existing - Retrofit existing infiltration swale to serve as pre-treatment for F2	1	0.47	0.53	0.47	1,717	1,200
F2	Proposed wet pond in existing ditch, partial pre-treatment from F1	2	1.12	0.88	0.56	4,022	4,022
G	Proposed - InfiltraCon or sand filter for new sand/salt shed	0.31	0.31	0	1	1,069	1,069

H	Existing - Enhance infiltration swale and improve existing pre-treatment swale	0.5	0.12	0.38	0.24	483	483
						Potential Total Volume (cf)	10,865
						3-acre Requirement (cf)*	8,200

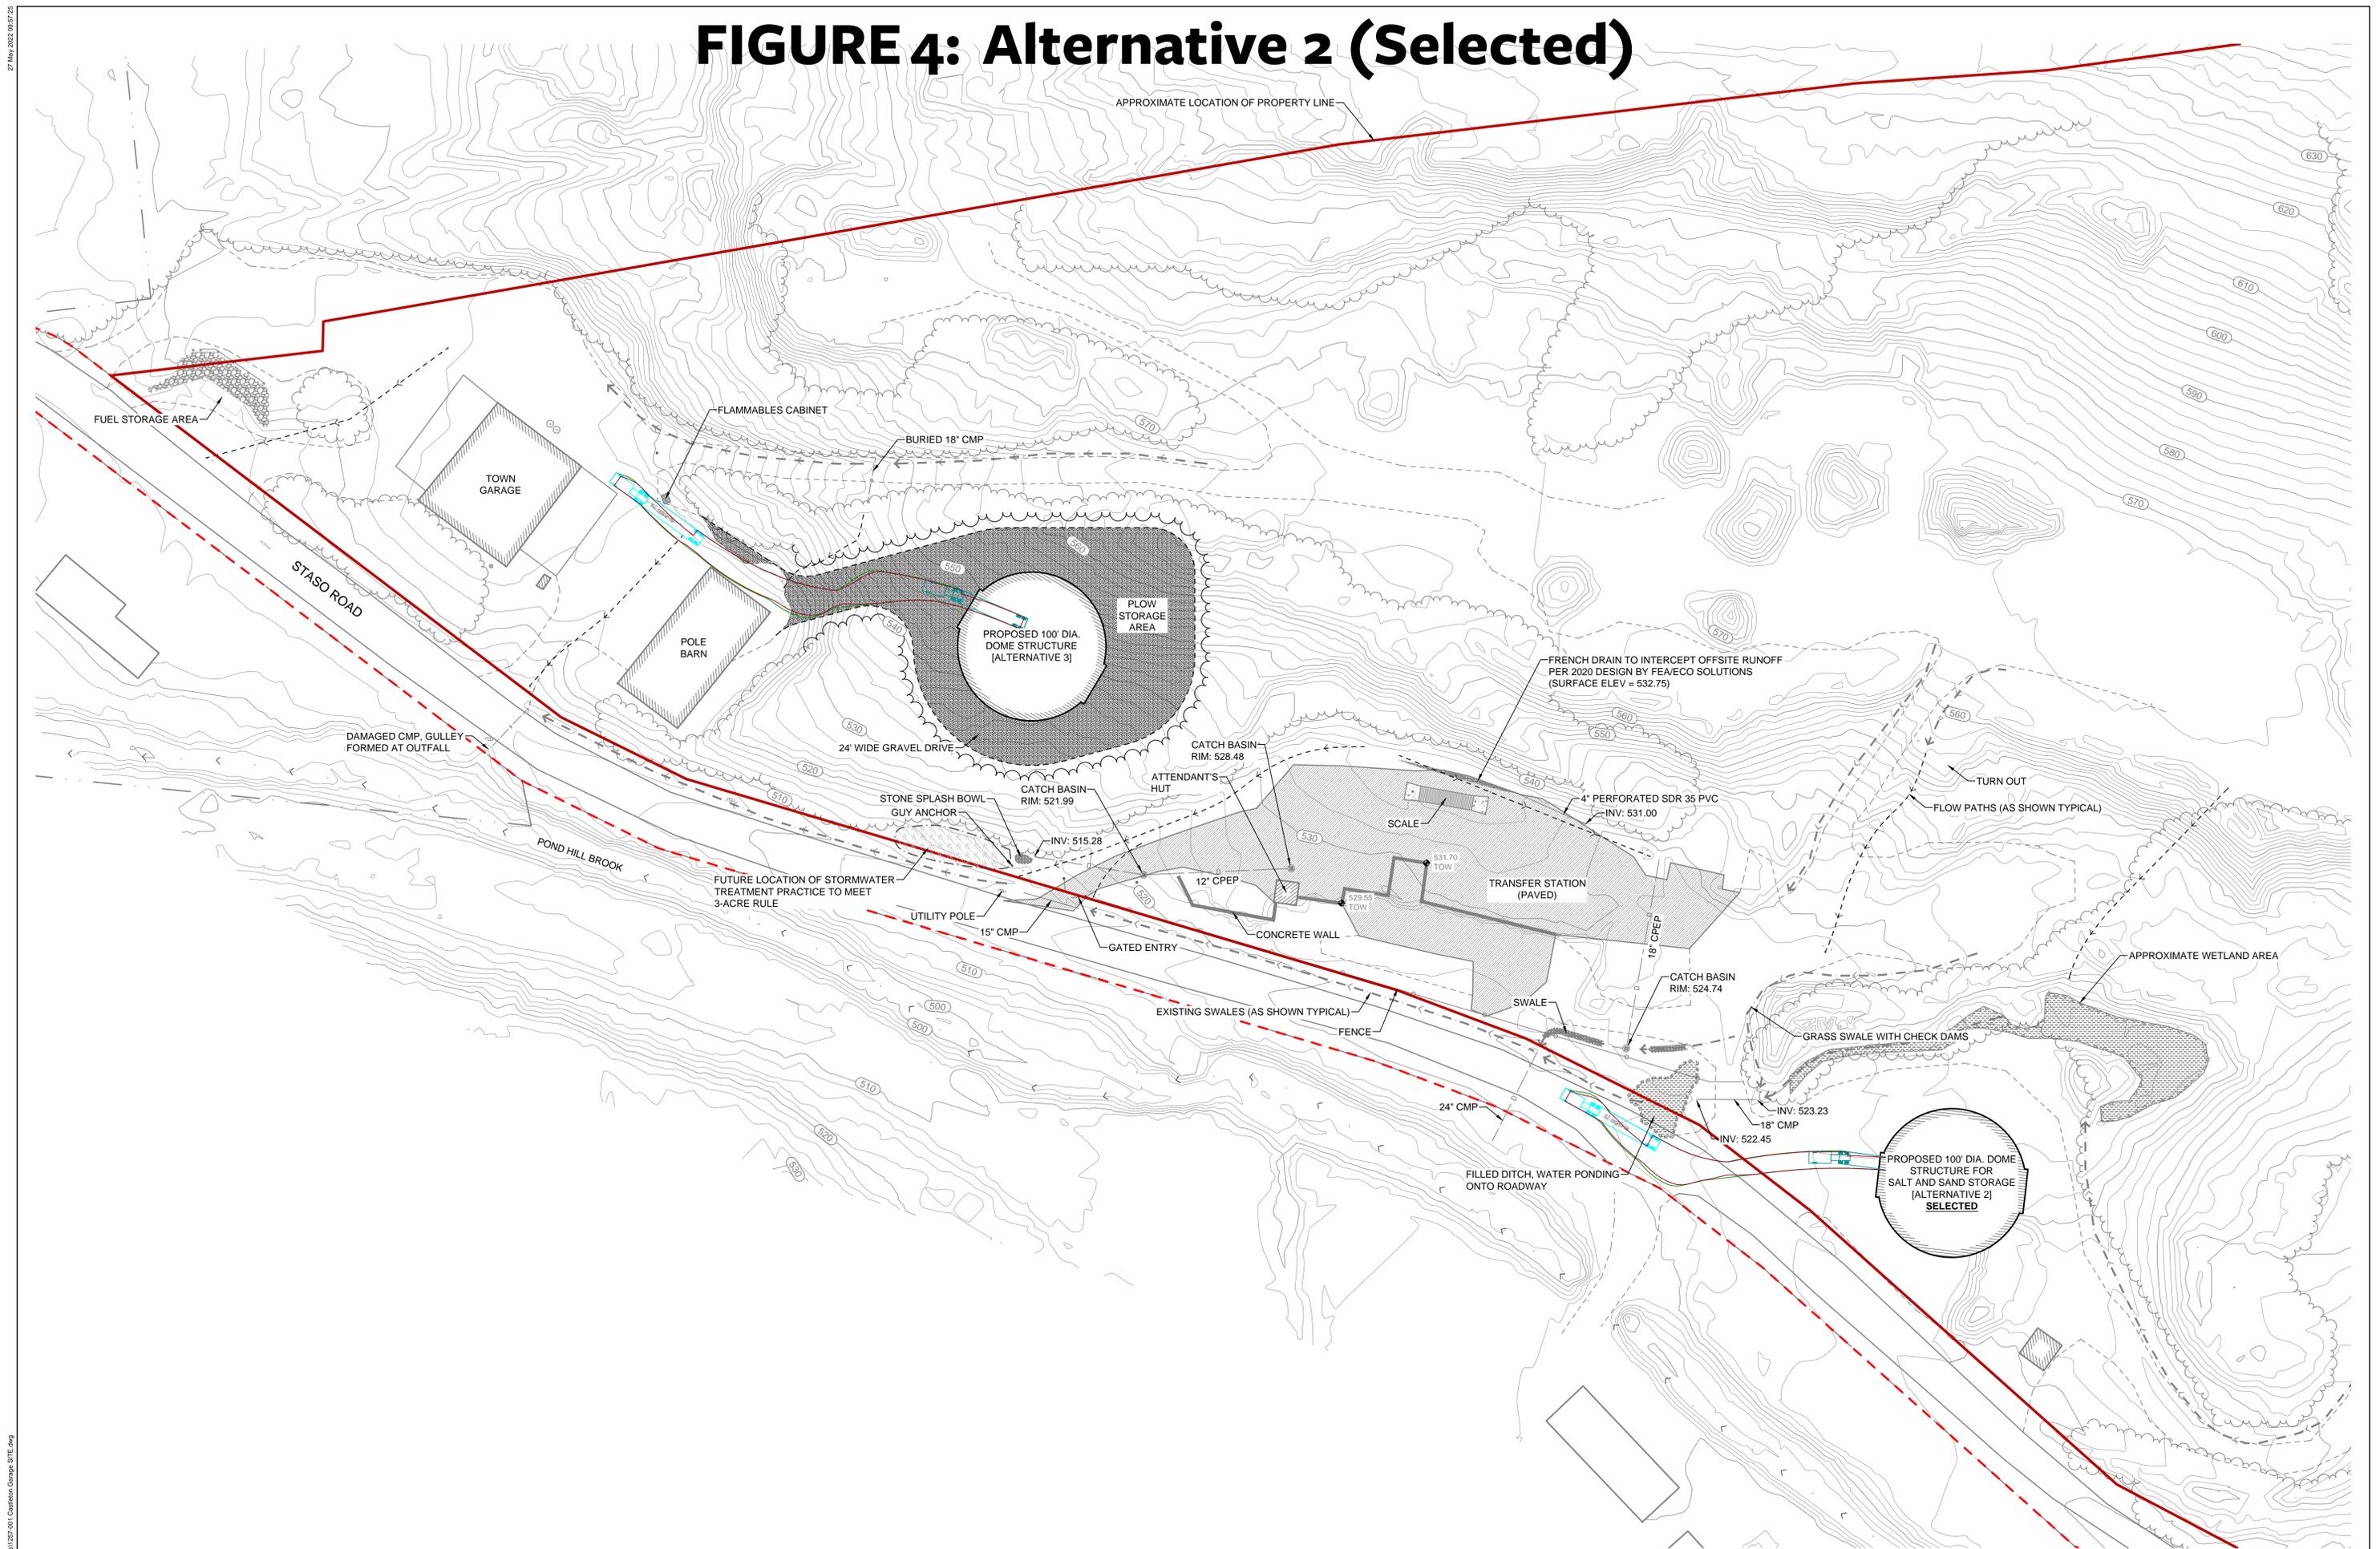
# FIGURE 4: Alternative 2 (Selected)

An alternatives presentation was held on December 13th 2021 to obtain input from the public. Alternative 2, which replaces the salt and sand shed at its current location, was selected (see **Figure 4: Alternative 2**) as it meets the projects needs while being the lowest cost build option.

## 5.0 SELECTED ALTERNATIVE CONSIDERATIONS

As noted in Section 3.2 above, Alternative 2 has been selected, this alternative is to construct a new Salt and Sand Shed located at the existing shed location. The following considerations should be evaluated during the next phase:

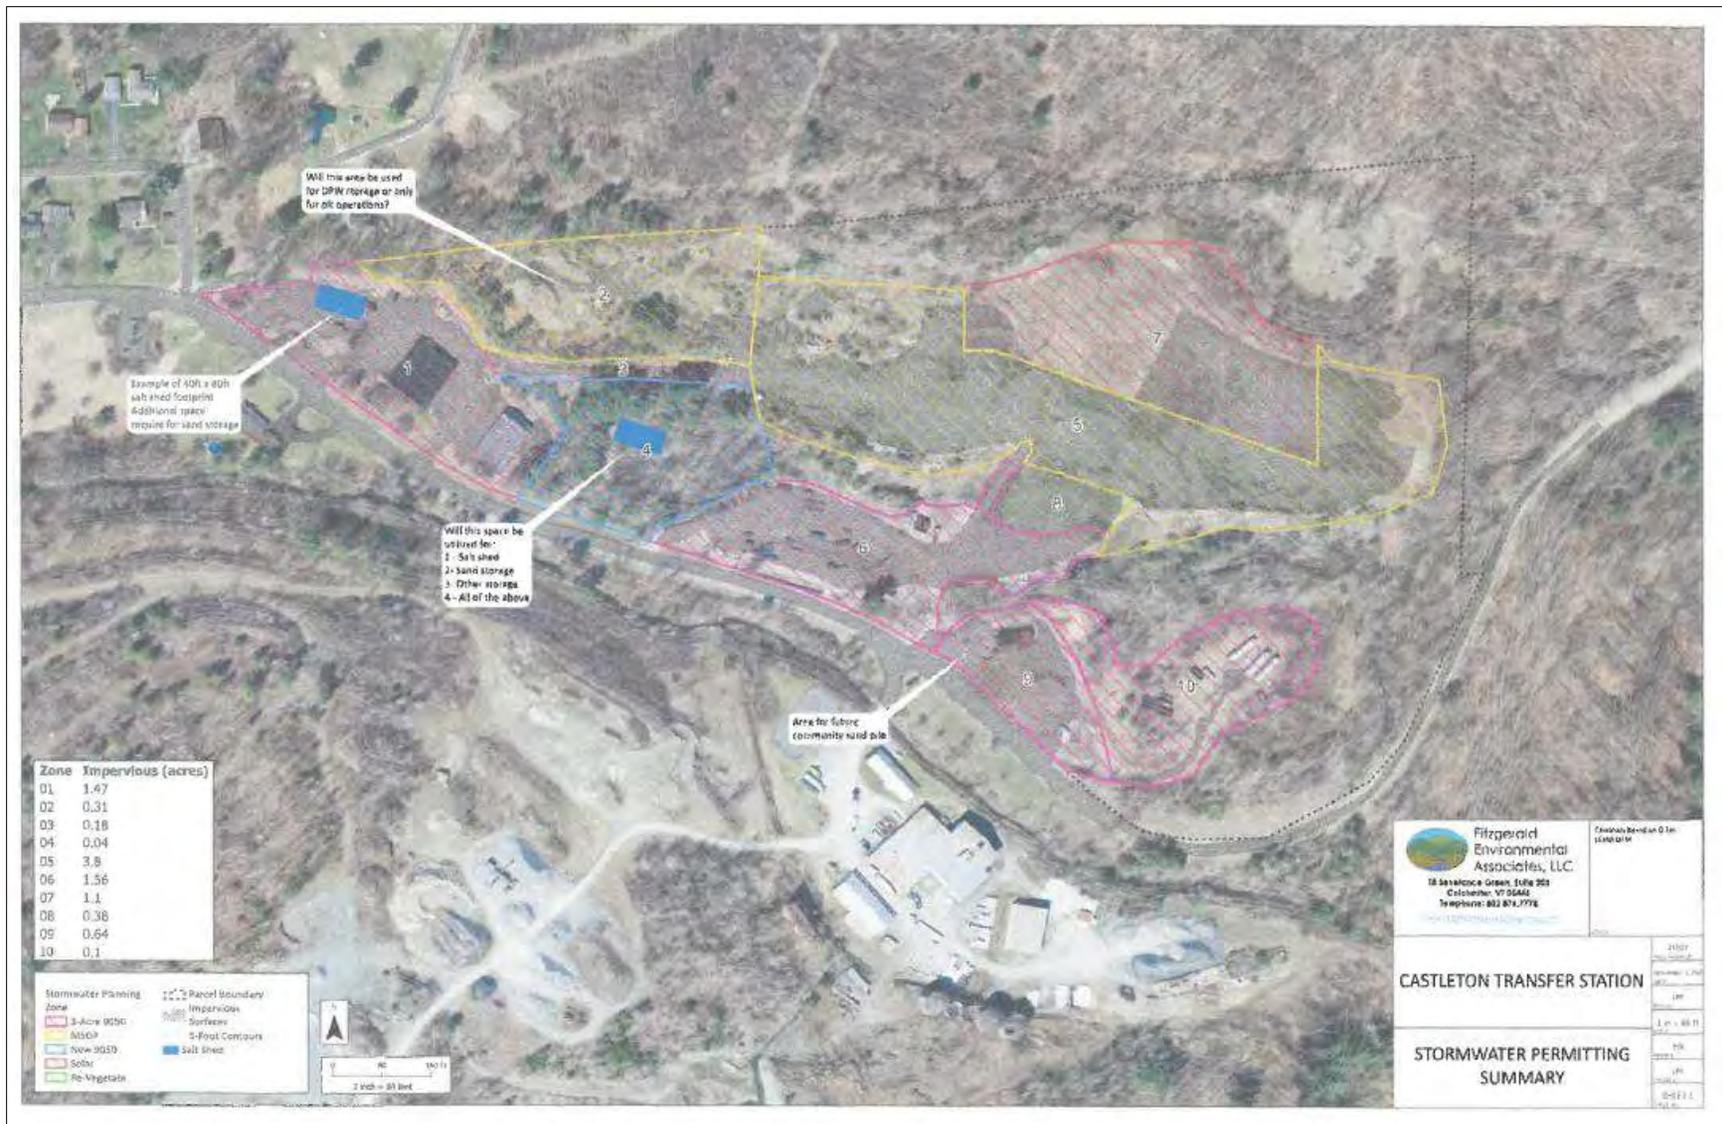
Figure 3. Preliminary map showing potential salt shed locations (blue rectangles) within the Castleton TAP TA 19(3) Staso Road Stormwater Scoping Study project area, Castleton, Rutland County, Vermont.

The field inspection also confirmed that the two areas currently identified as possible new salt shed locations are not sensitive (see Figure 3). The location at the very western end of the project area, to the west of the highway department garages, is on a paved surface that appears to have been leveled (Figure 29). The location to the east of the highway department buildings is a steep slope, that also appears to have been disturbed by earth movement (Figures 30 and 31).

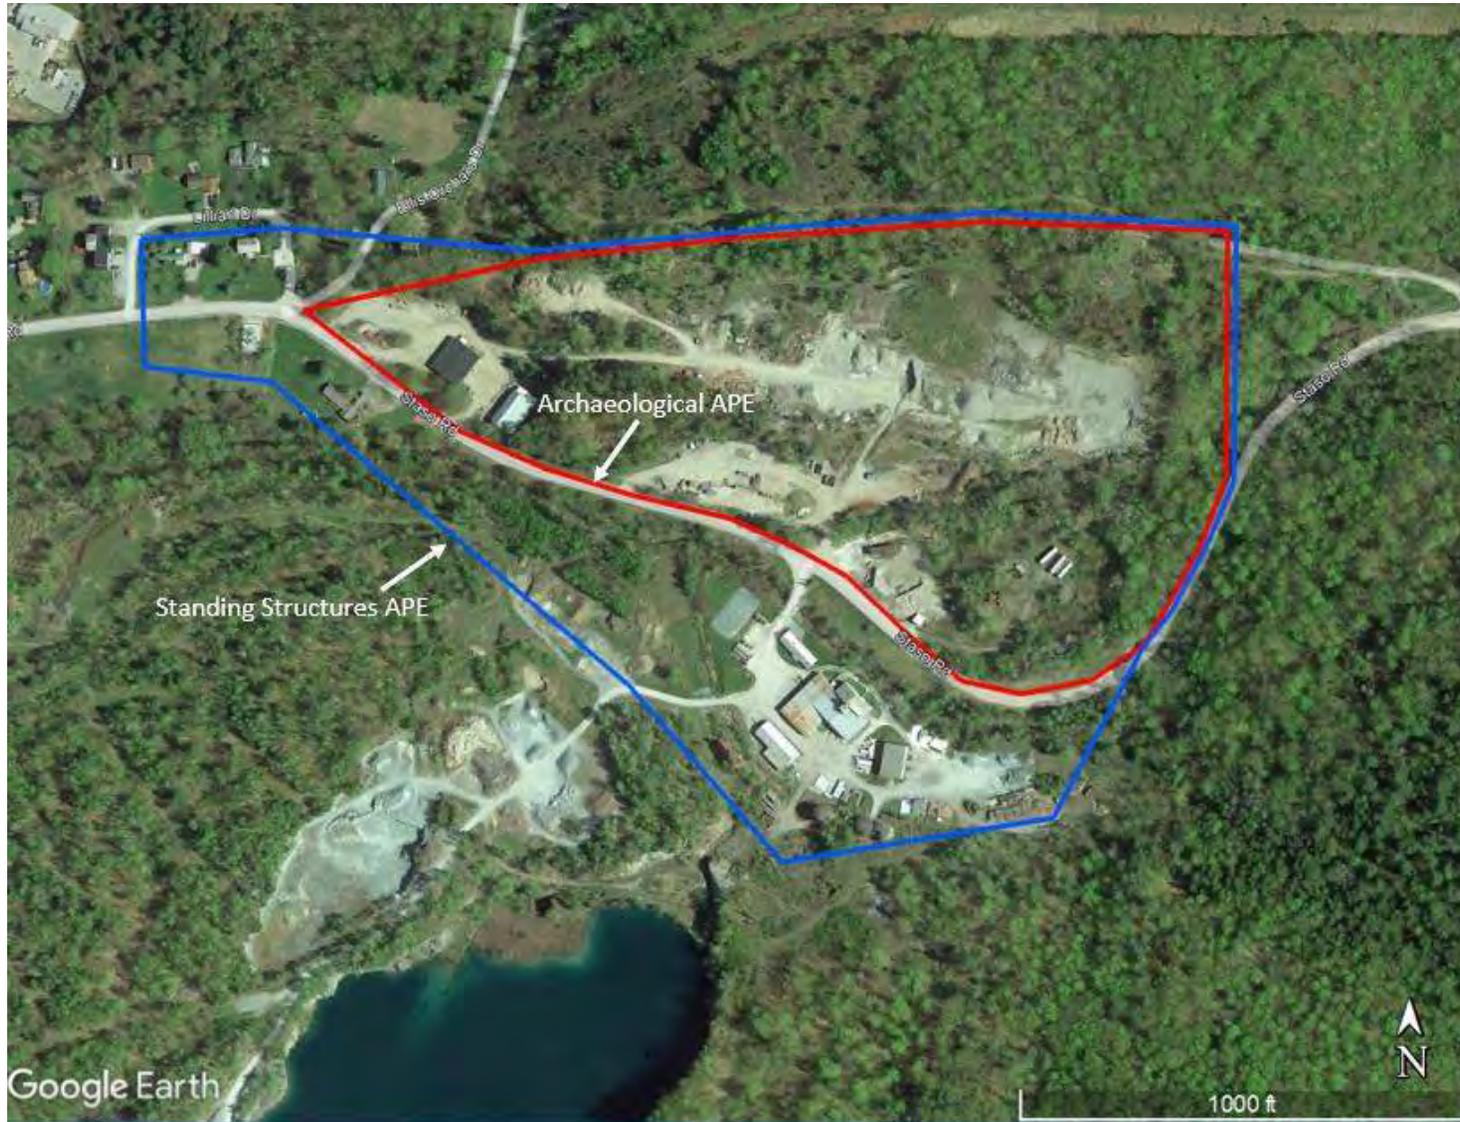
Figure 4. Map showing the archaeological and standing structures Areas of Potential Effect (APE) for the Castleton TAP TA 19(3) Staso Road Stormwater Scoping Study, Castleton, Rutland County, Vermont.

The objective of the HRR is to identify and document any historic resources on or eligible for listing on the National and/or State Register of Historic Places that have the potential to be directly or indirectly affected by project work, and if present, to recommend a determination of effect on the resources by the proposed project. The proposed project was reviewed according to standards set forth in 36 CFR Part 800, the regulations established by the Advisory Council on Historic Preservation to implement Section 106 of the National Historic Preservation Act, and its amendments. The Area of Potential Effect (APE) for standing historic resources was identified as the project parcel and nearby properties along Staso Road and Ellis Orchard Drive that are in view of the project parcel (Figure 4).

The goals of the ARA are to identify any portions of the project's APE that may contain pre-Contact Native American and/or historic archaeological sites, to provide sufficient information to gauge their potential for archaeological significance, and to recommend if further archaeological work would be needed prior to project work. To assess the potential of the proposed project's APE for pre-Contact Native American sites, a review of the files maintained by the Vermont Division of Historic Preservation (VDHP) was undertaken to identify the location and nature of nearby previously reported sites in order to understand the archeological potential of the general area. Additionally, the criteria outlined in the VDHP's *Environmental Predictive Model for Locating PreContact Archaeological Sites* were used to establish the general sensitivity for Pre-Contact Native American sites within the proposed APE. The Area of Potential Effect for archaeological resources was identified as the project parcel (see Figure 4).

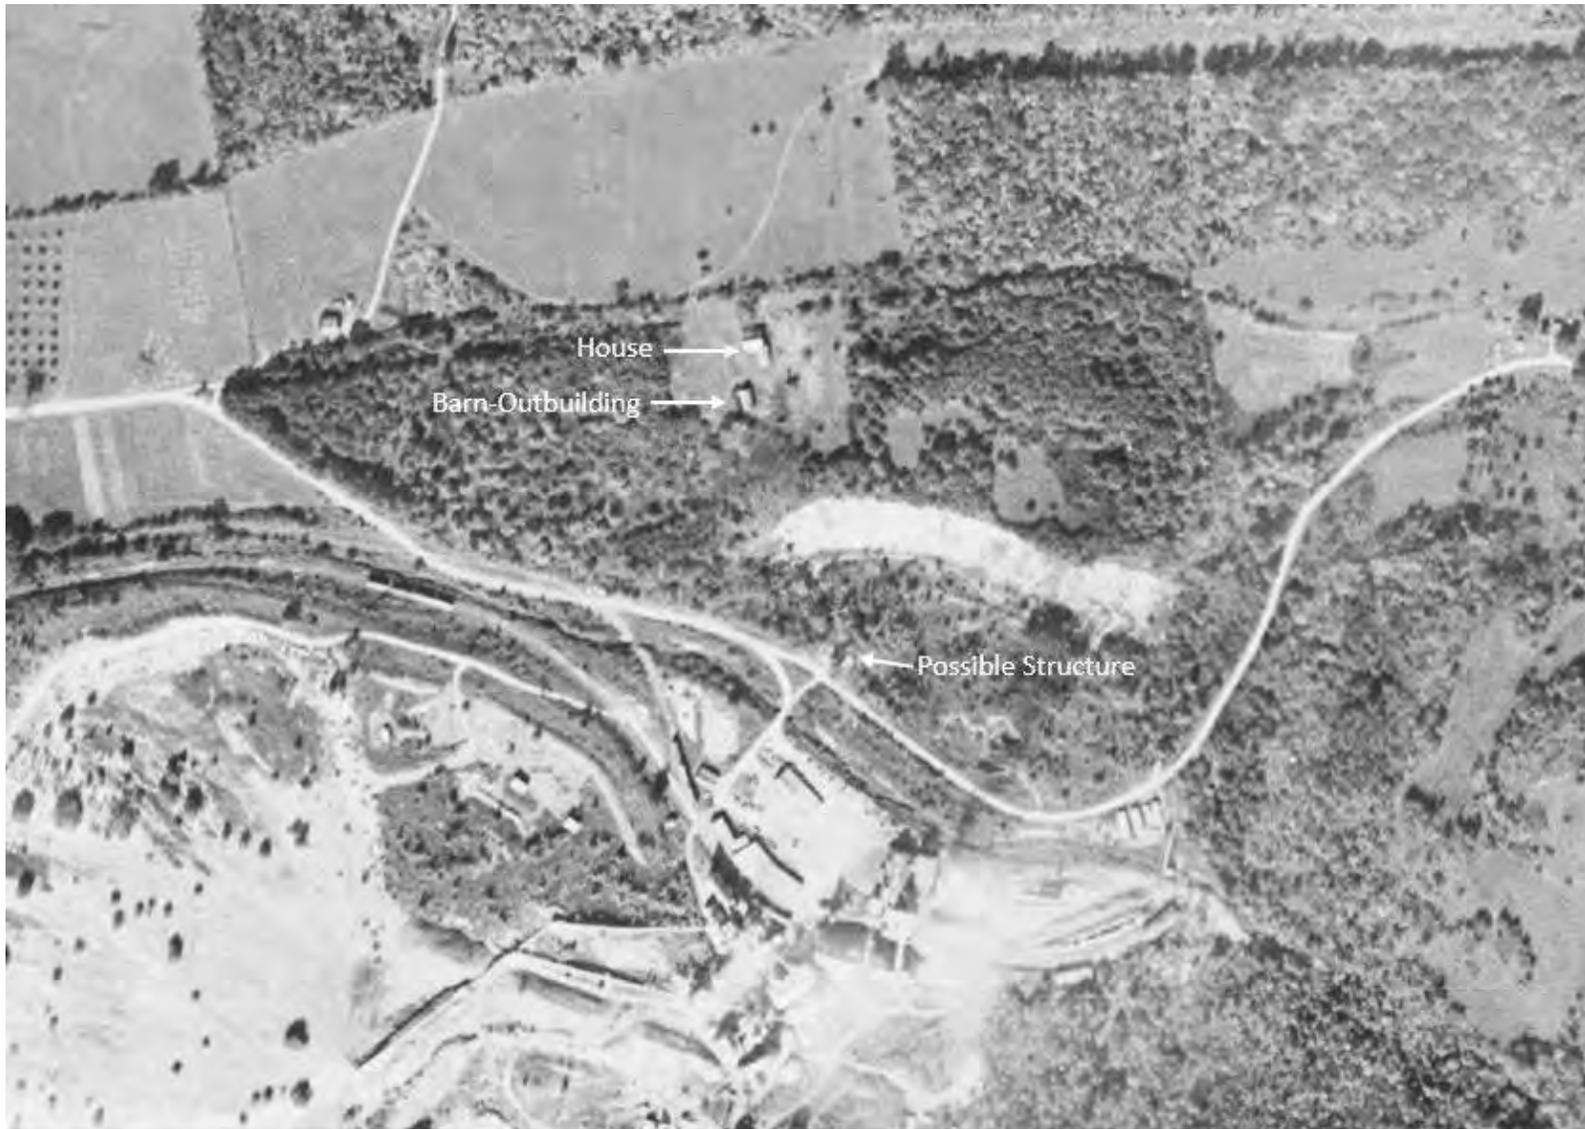
Figure 8. Detail from 1942 aerial image showing the location of the former house and barn / outbuilding, and a possible second structure, within the project area; also note area south of the house that appears extensively quarried by this time.

The portion of the project area adjacent to Staso Road where the highway department buildings, transfer station, salt shed and sand pile are located, appears to have formerly been sloped and heavily modified by leveling, earth moving and fill to accommodate the structures (Figures 13 – 20). The eastern end of this area was also likely quarried in the early 20<sup>th</sup> century (see Figure 8).

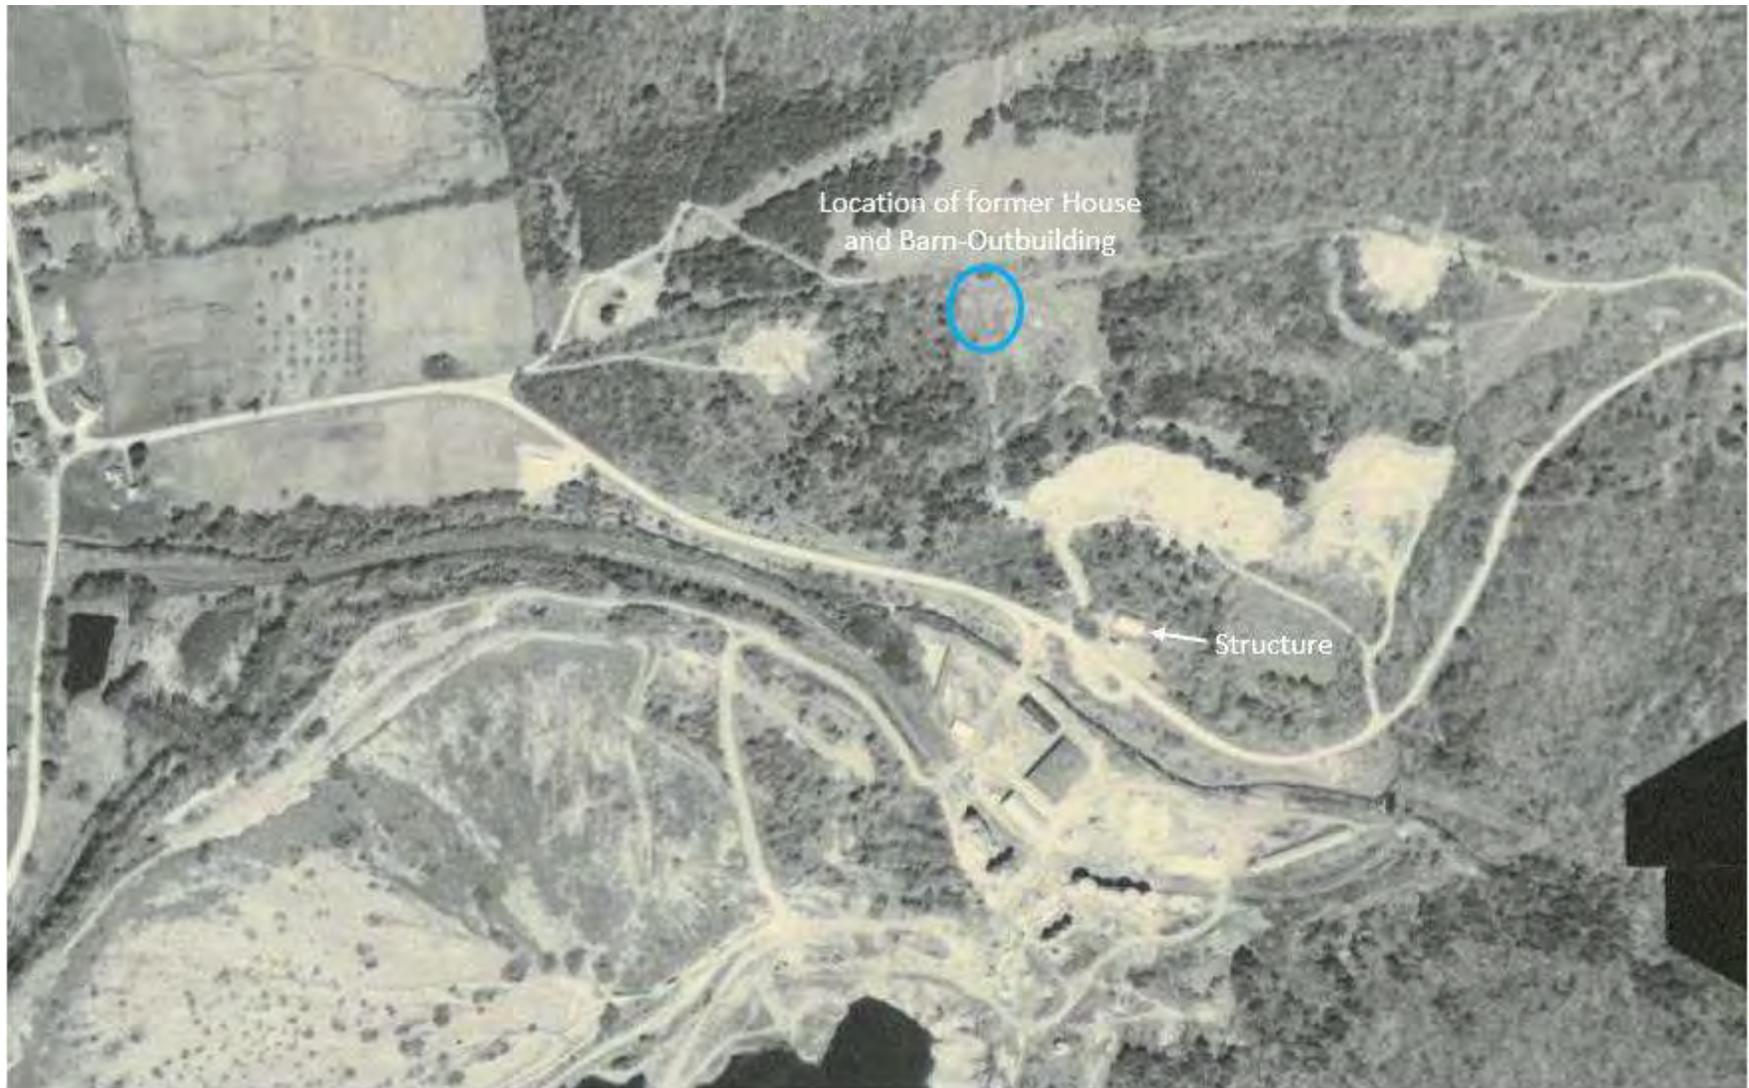
Figure 9. Detail from 1962 aerial image showing the location of the former house and barn / outbuilding and a second structure within the project area.

Town owned buildings or structures within the project area appear to date to the 1990s or later and are not considered historic (see Figures 13 – 18) (Google Earth). A structure that appears in the 1962 aerial may remain at the site, near the existing sand pile and salt shed, but it is not recommended as State or National Register eligible (see Figures 9 and 20).
