# Stormwater Scoping Study

## Castleton | Staso Road

Castleton TAP TA 19(3) Staso Road Stormwater Scoping Study

MSK Engineers

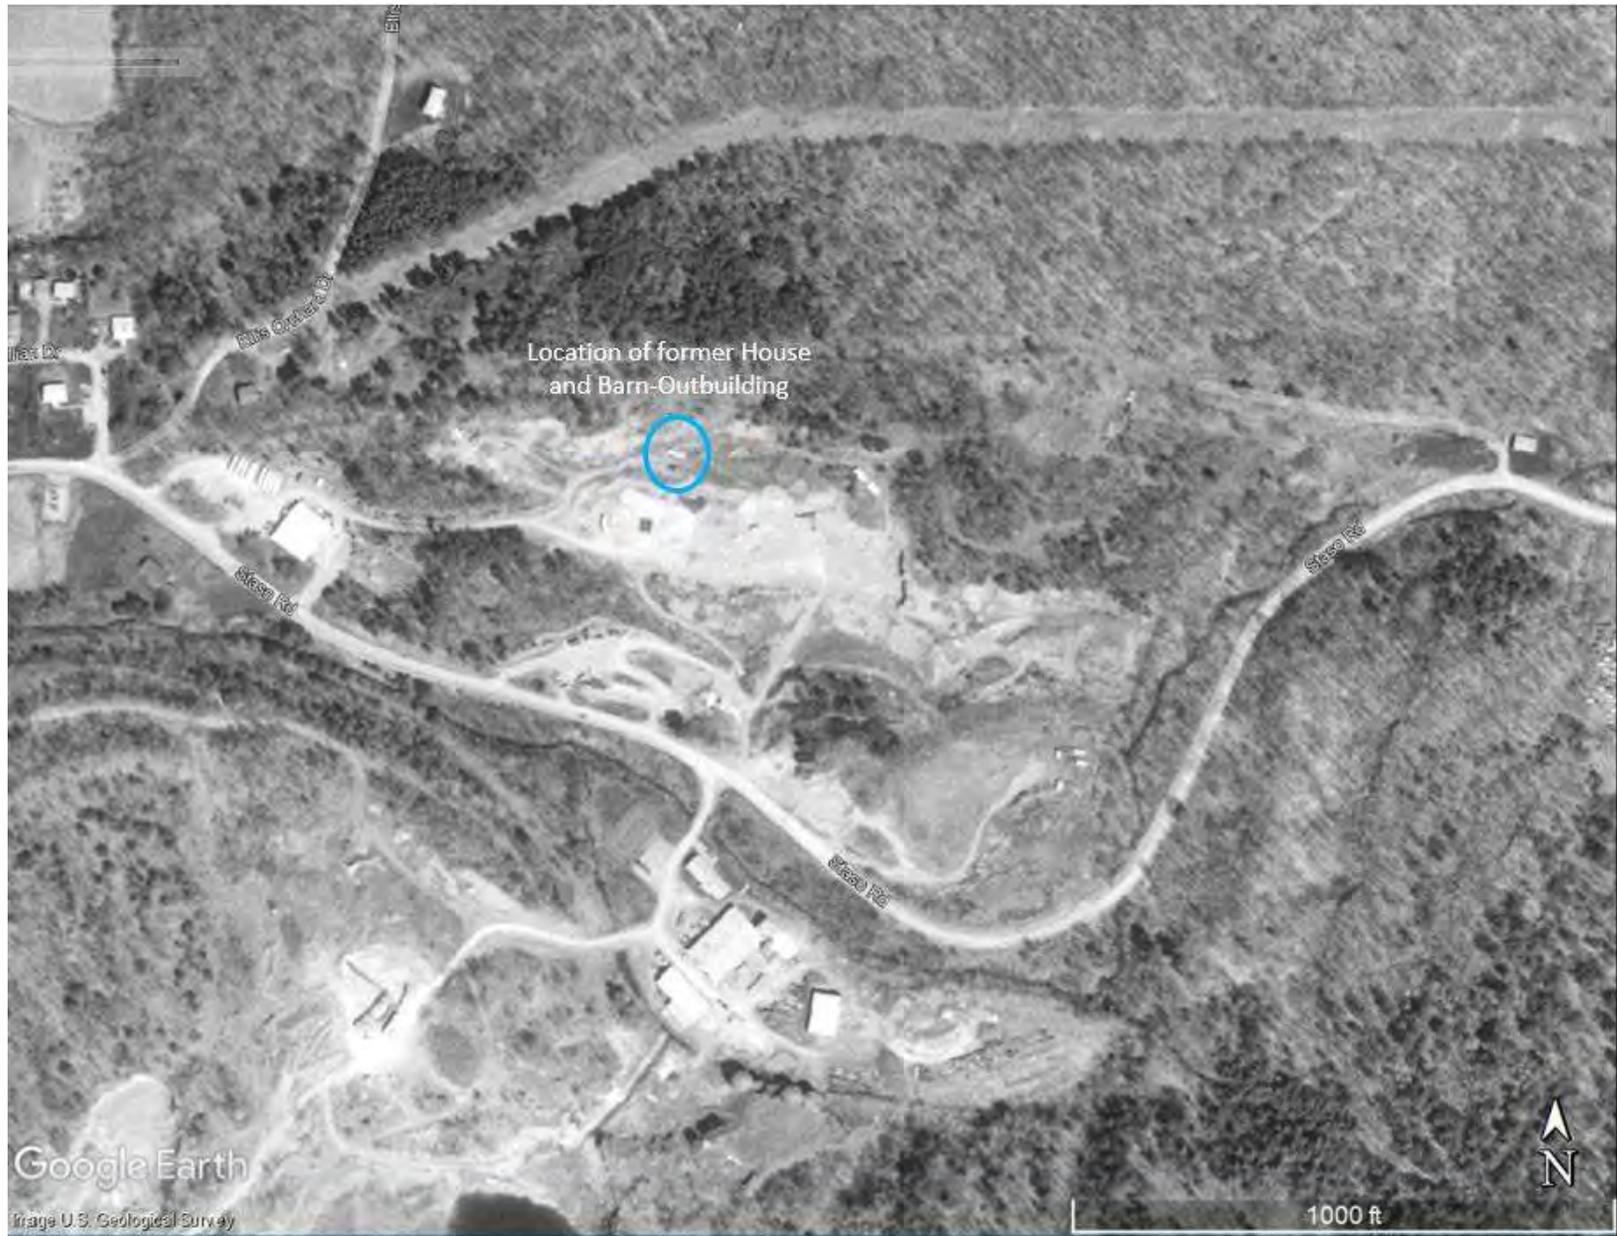
Figure 10. Google Earth image showing the location of the former house and barn / outbuilding in 1994.

Historic maps and research indicate that a dwelling associated with a farmstead was constructed within the north portion of the project area c. 1840 (see Figures 5 – 8). A house, along with a barn / outbuilding, stood within the parcel until at least 1942; it was no longer extant by 1962 and by 1994, it appears that its location may have been heavily modified (see Figures 9 and 10). This area was identified as potentially sensitive for historic era Euroamerican sites (see Figure 12).

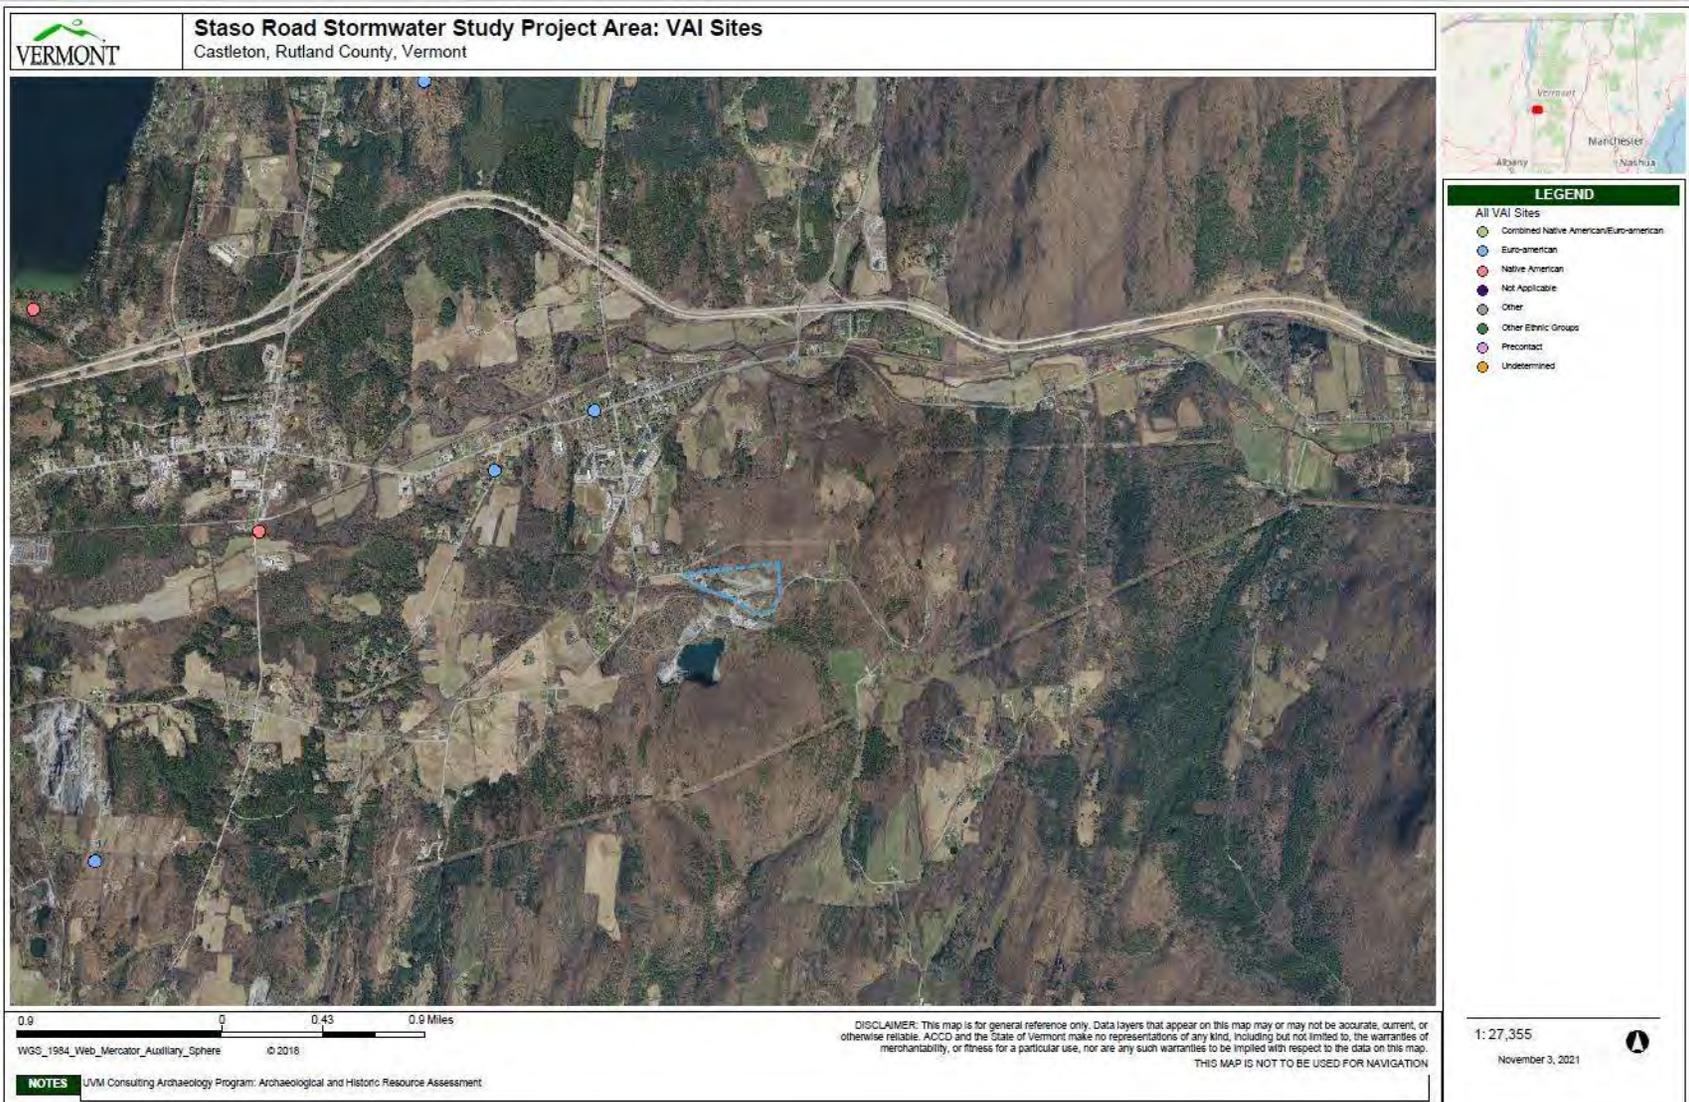
Figure 11. Map showing the location of known historic (blue) and pre-Contact Native American (red) archaeological sites near the Castleton TAP TA 19(3) Staso Road Stormwater Scoping Study project area, Castleton, Rutland County, Vermont (VACCD ORC).

A review of the VAI indicates that no historic era Euroamerican sites are designated within the project area (see Figure 11). The closest mapped historic sites in the VAI are VT-RU-0589, located approximately 1.4 km (0.9 miles) northwest of the project area, and VT-RU-0590, located approximately 1.4 km (0.8 miles) northwest of the project area, along or just south of VT Route 4A. VT-RU-0589 consists of a subsurface burn episode with late 19<sup>th</sup> and early 20<sup>th</sup> century artifacts and VT-RU-0590 consists of foundation remains with undated artifacts.

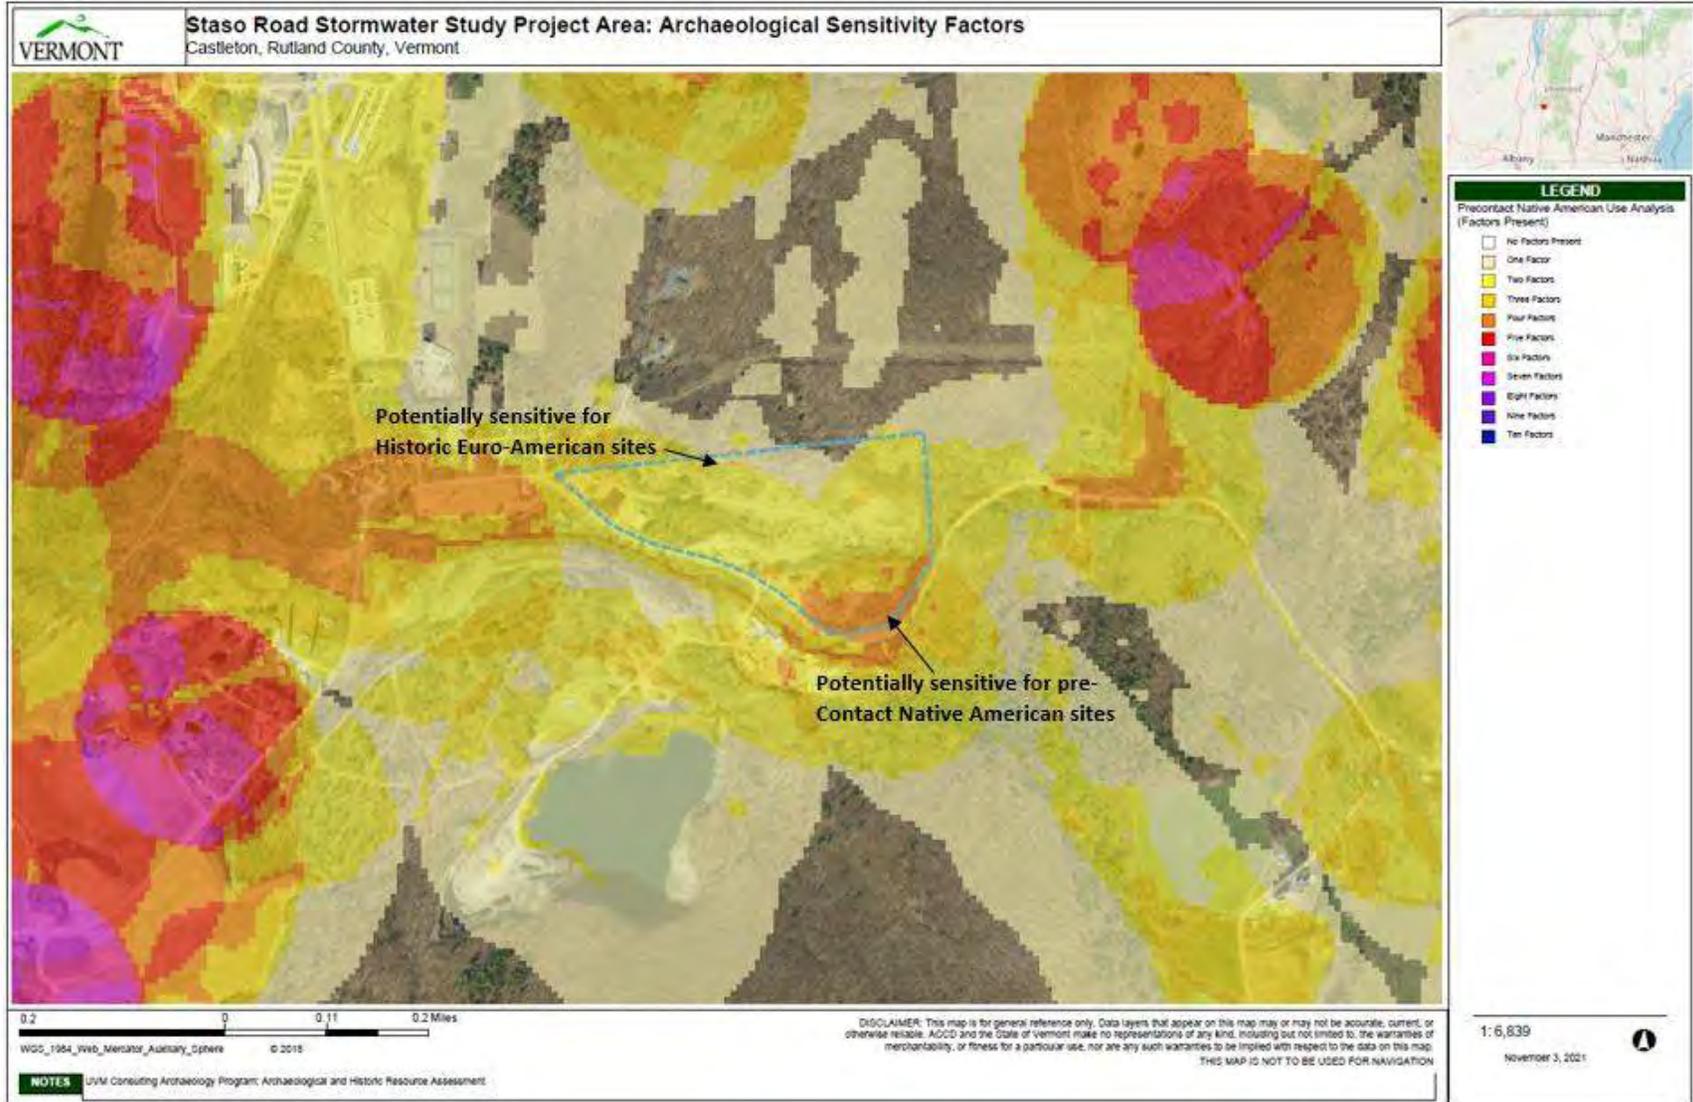
Figure 12. GIS based Archeological Sensitivity Map for the Castleton TAP TA 19(3) Staso Road Stormwater Scoping Study project area, Castleton, Rutland County, Vermont, with areas identified as potentially sensitive (VACCD ORC).

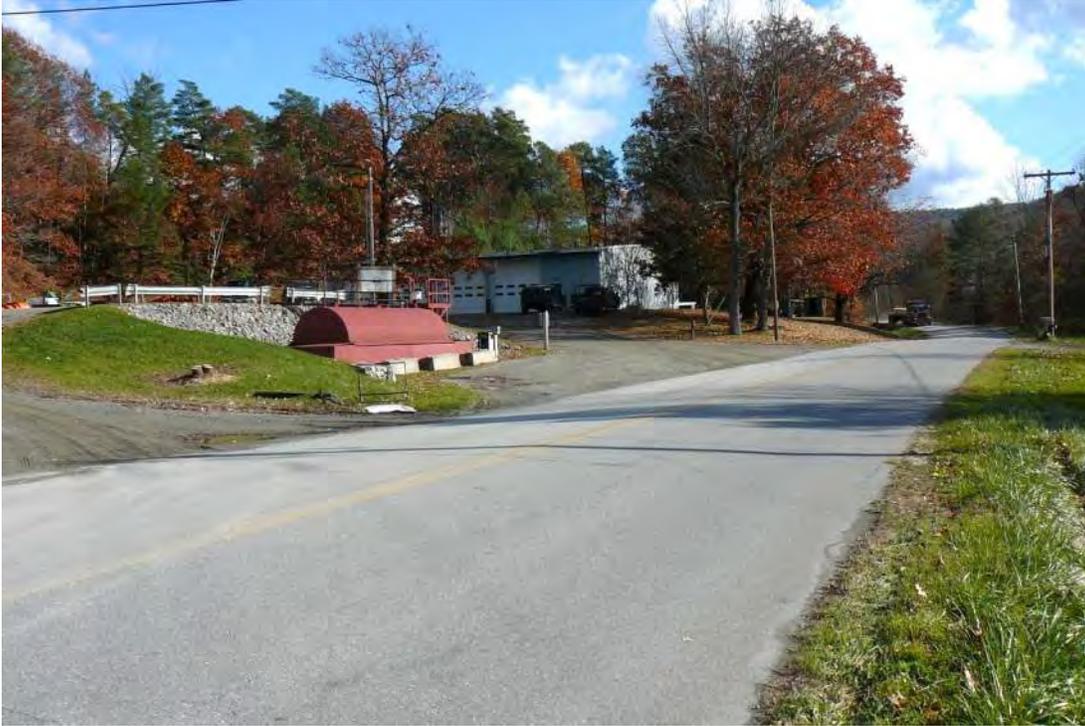
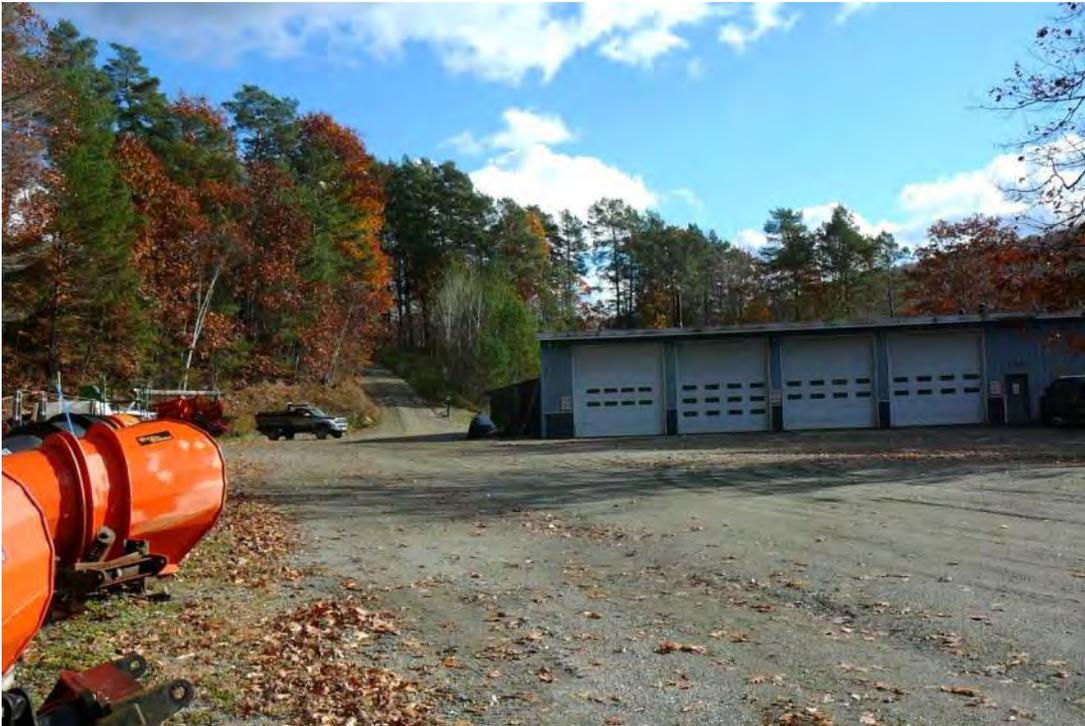
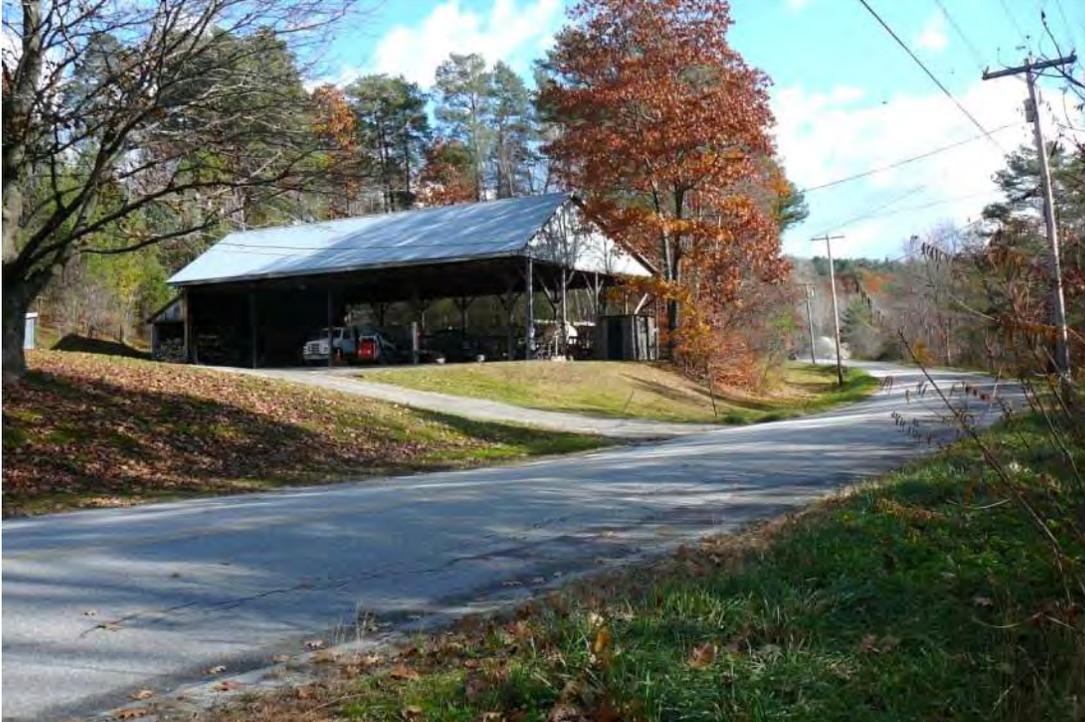
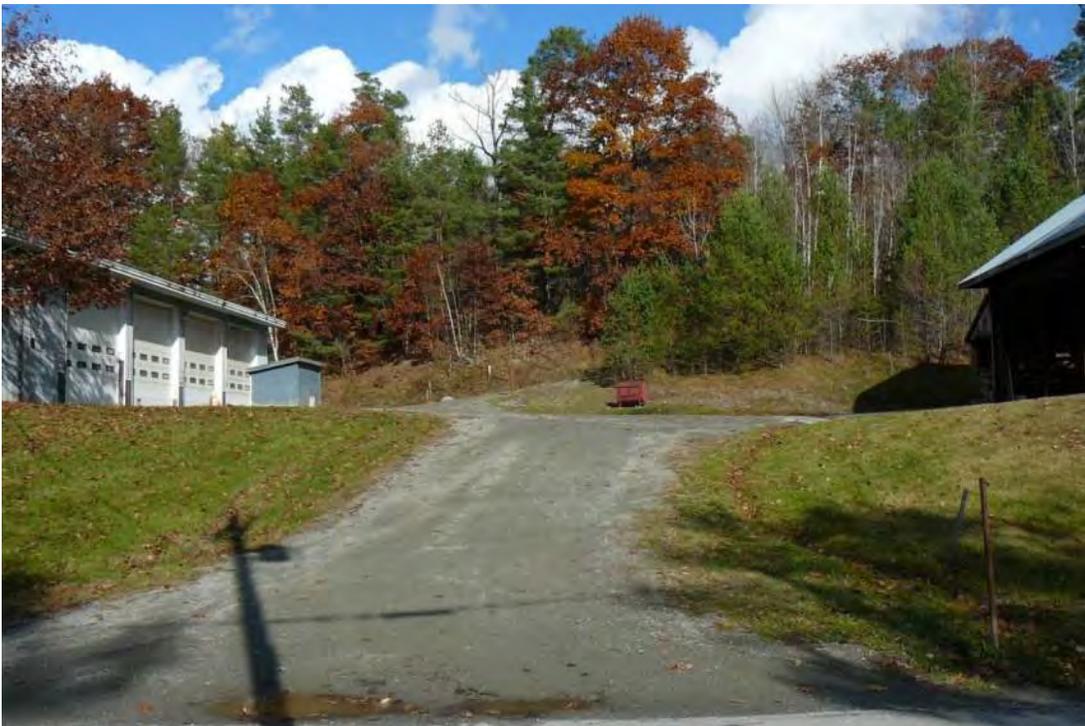
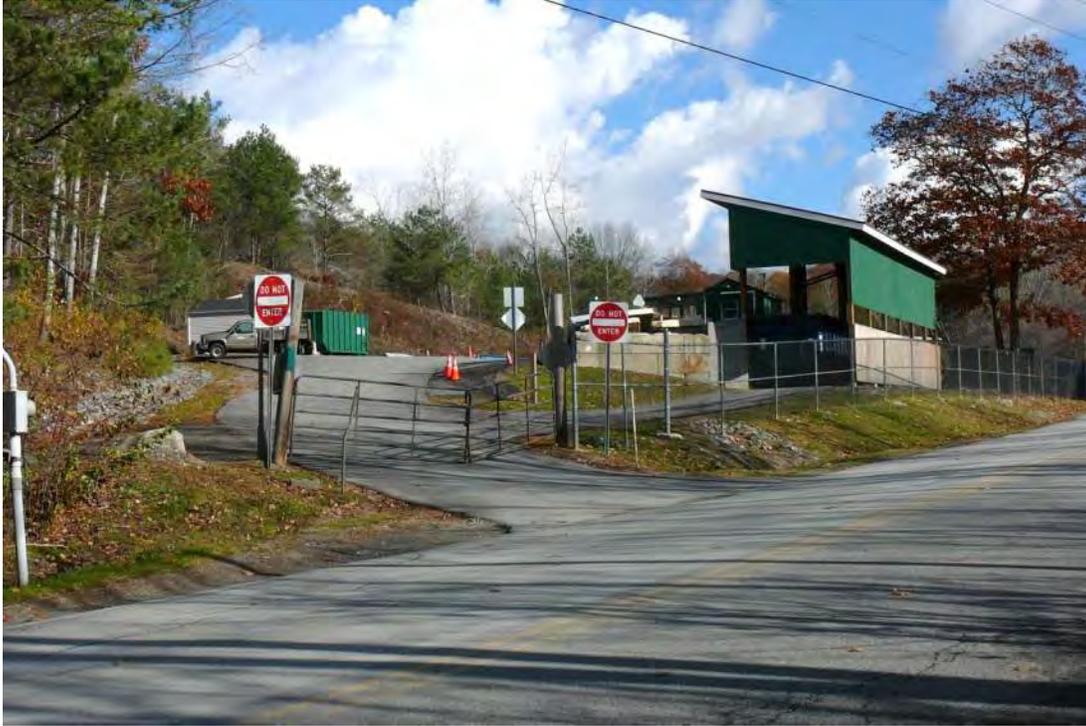
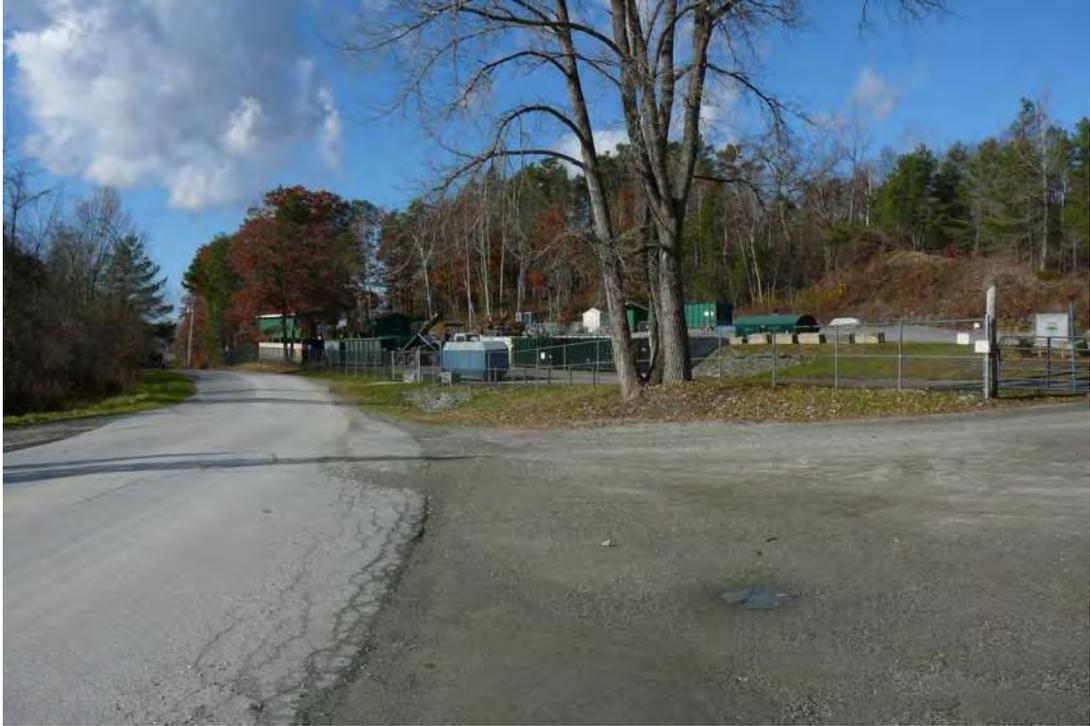
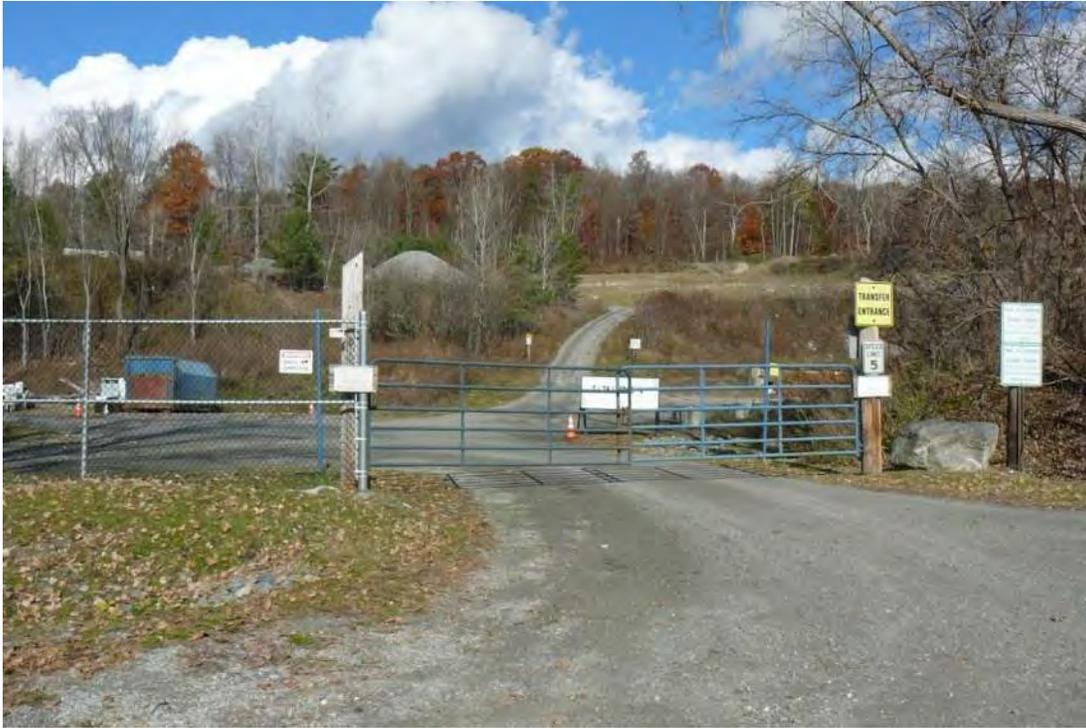
Figure 13. View east along Staso Road at the west end of the project area; highway department structures at left.

Figure 14. View northeast in the west end of the project area; highway department structure at right.

Figure 15. View northeast along Staso Road at the west end of the project area; highway department structure at left.

Figure 16. View northeast from Staso Road between highway department structures at the west end of the project area.

Figure 17. View southeast along Staso Road at the central portion of the project area; transfer station structures at center.

Figure 18. View northwest along Staso Road at the central portion of the project area; transfer station structures at background.

Figure 19. View northeast into the central portion of the project area; transfer station entrance gate in foreground.

The portion of the project area adjacent to Staso Road where the highway department buildings, transfer station, salt shed and sand pile are located, appears to have formerly been sloped and heavily modified by leveling, earth moving and fill to accommodate the structures (Figures 13 – 20). The eastern end of this area was also likely quarried in the early 20<sup>th</sup> century (see Figure 8).

Town owned buildings or structures within the project area appear to date to the 1990s or later and are not considered historic (see Figures 13 – 18) (Google Earth). A structure that appears in the 1962 aerial may remain at the site, near the existing sand pile and salt shed, but it is not recommended as State or National Register eligible (see Figures 9 and 20).

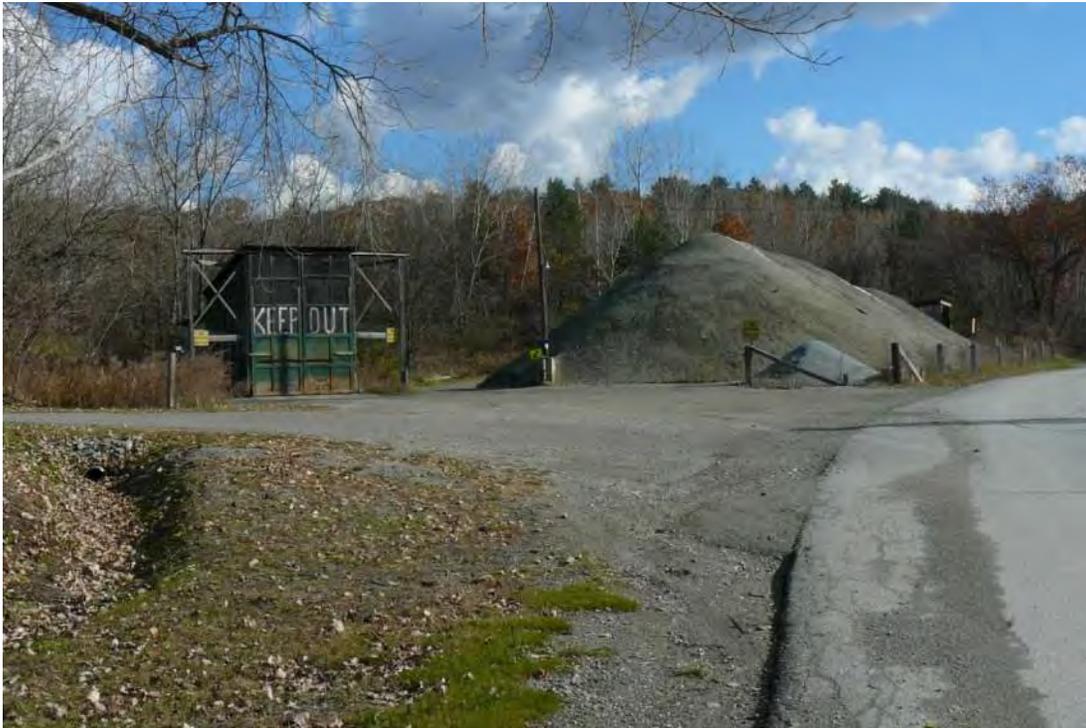
Figure 20. View southeast along Staso Road at the central portion of the project area; sand pile and salt shed structure (behind sand pile) at center.

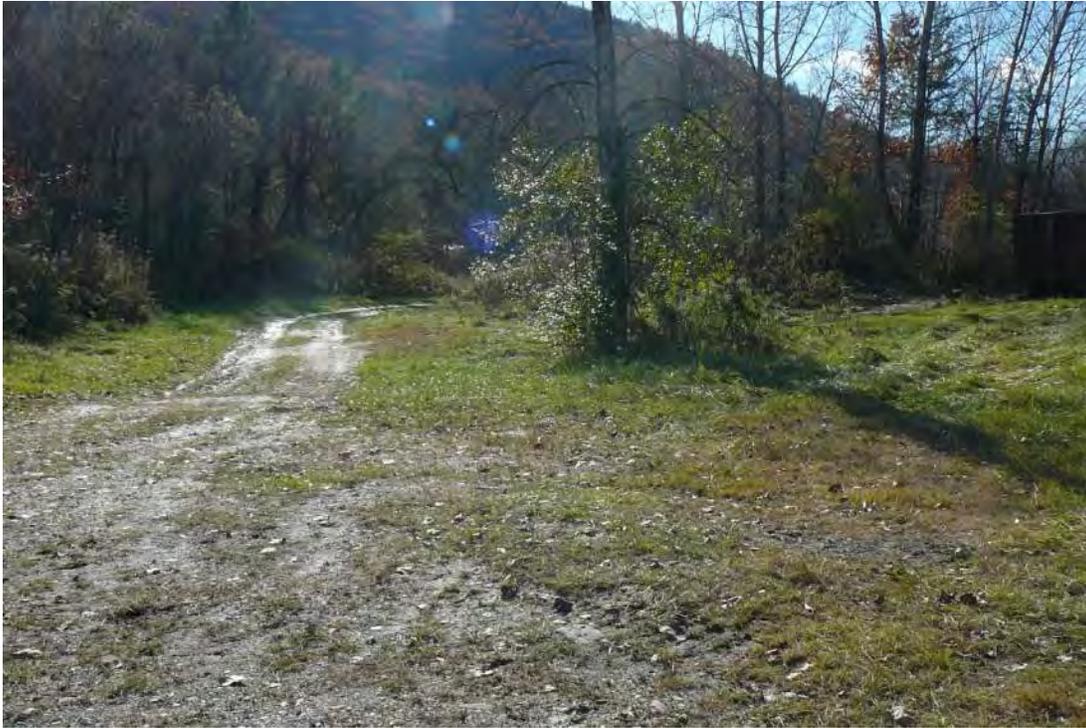
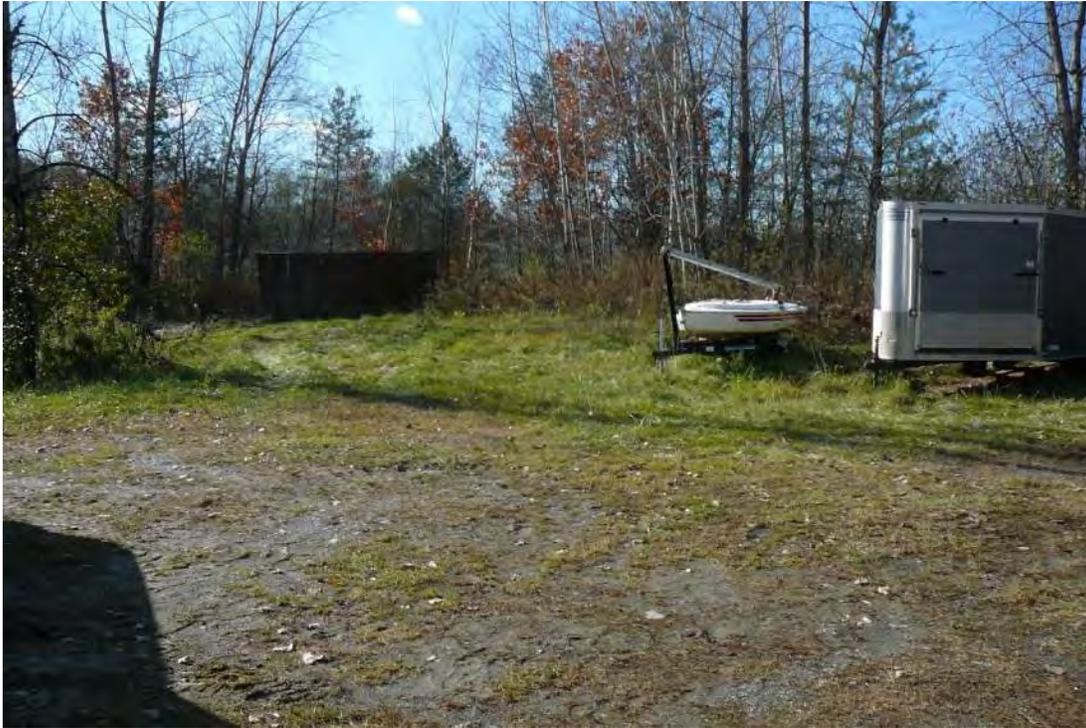
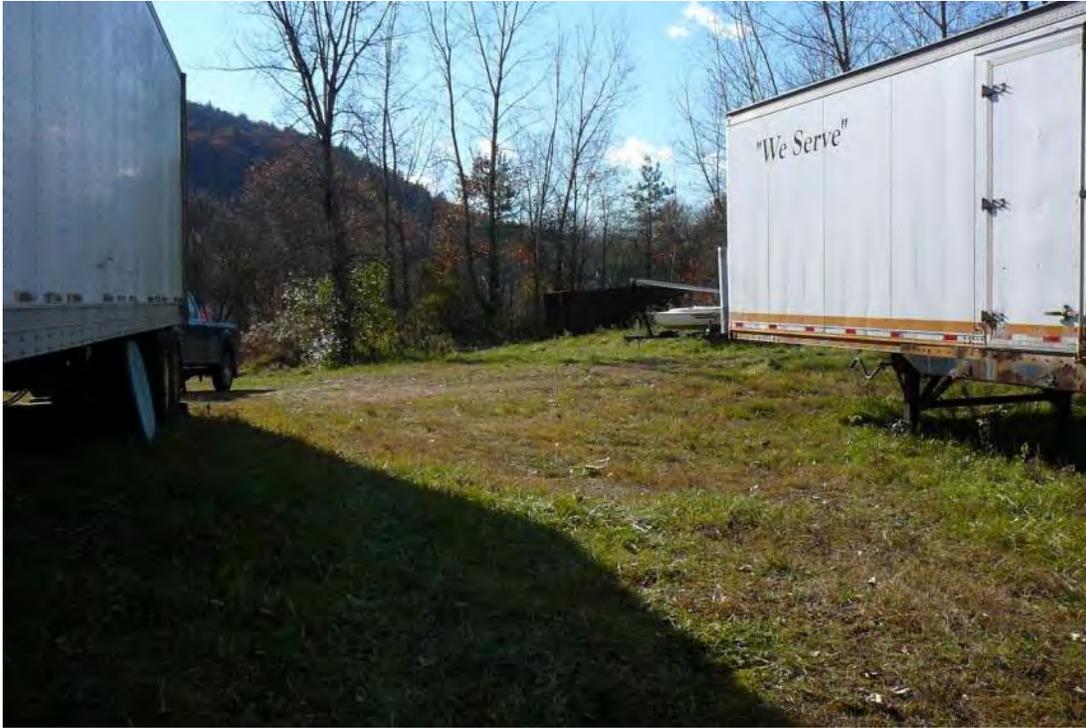
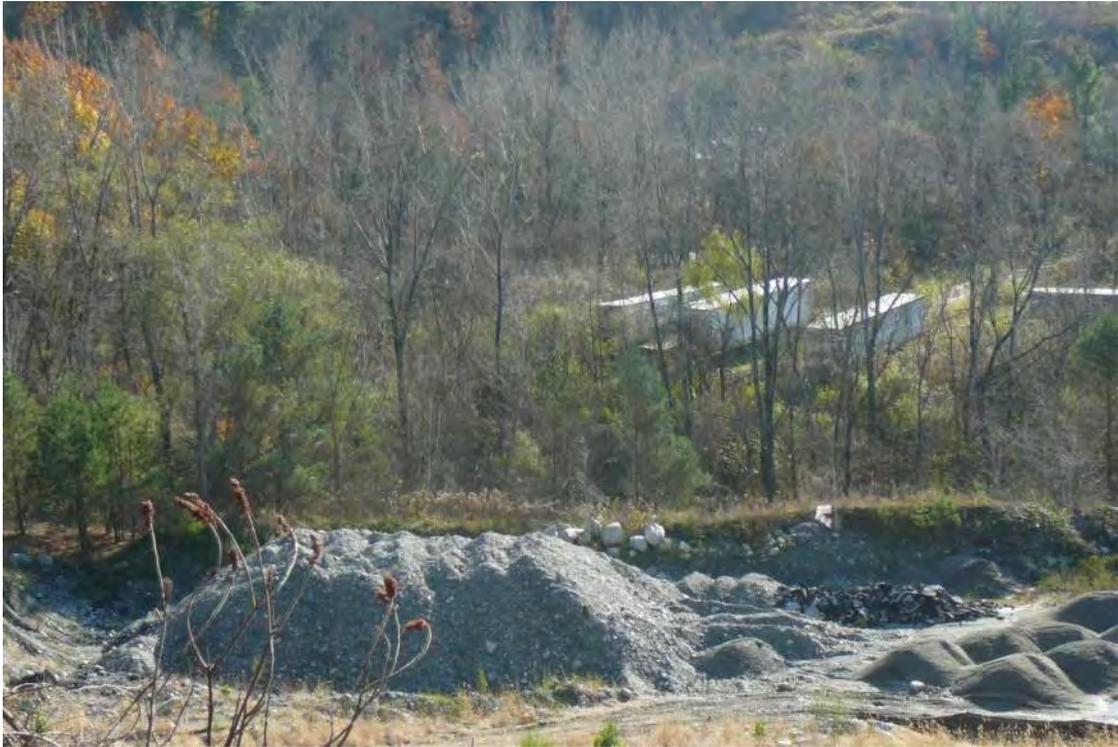
Figure 21. View southwest within the eastern end of the project area nearest Staso Road, at the storage area / former landfill location.

Figure 22. View west within the eastern end of the project area nearest Staso Road, at the storage area / former landfill location.

Figure 23. View southwest within the eastern end of the project area nearest Staso Road, at the storage area / former landfill location.

Figure 24. View south from the Quarry edge over the eastern end of the project area, at the storage area / former landfill location.

The east end of the project area along Staso Road, within the large curve of the road, is used for storage (Figures 21 – 24). Although a portion of this area was identified as potentially sensitive, most of the area was formerly a landfill that has been filled in / reclaimed (personal communication with Town Manager and observation). Prior to its use as a landfill, a large part of it was likely quarried (see Figure 8). The very eastern edge of this area is adjacent to an unnamed tributary that flows into Pond Hill Brook just outside of the project area, on the south side of Staso Road. It appears that the landfill extended very close to the stream, or that reclamation activity disturbed most of the landform here, as the ground surface has been moved around and various debris is visible within and on top of it (Figures 25 – 28). Immediately adjacent to the stream, soil cores indicated very recent deposits. To the north along the stream, the landform is excessively steep.

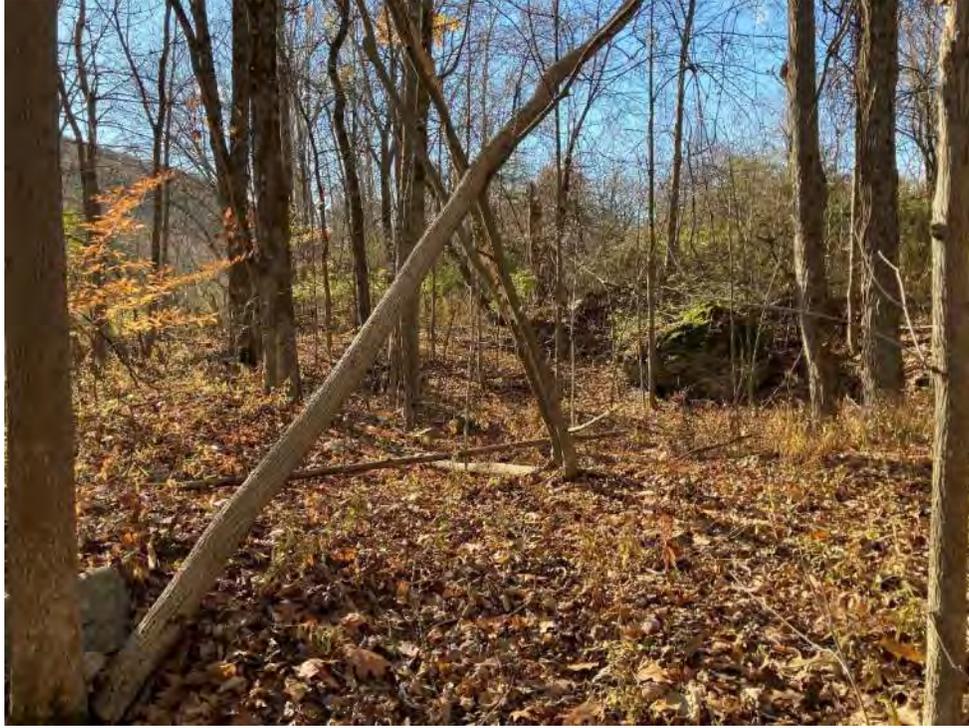
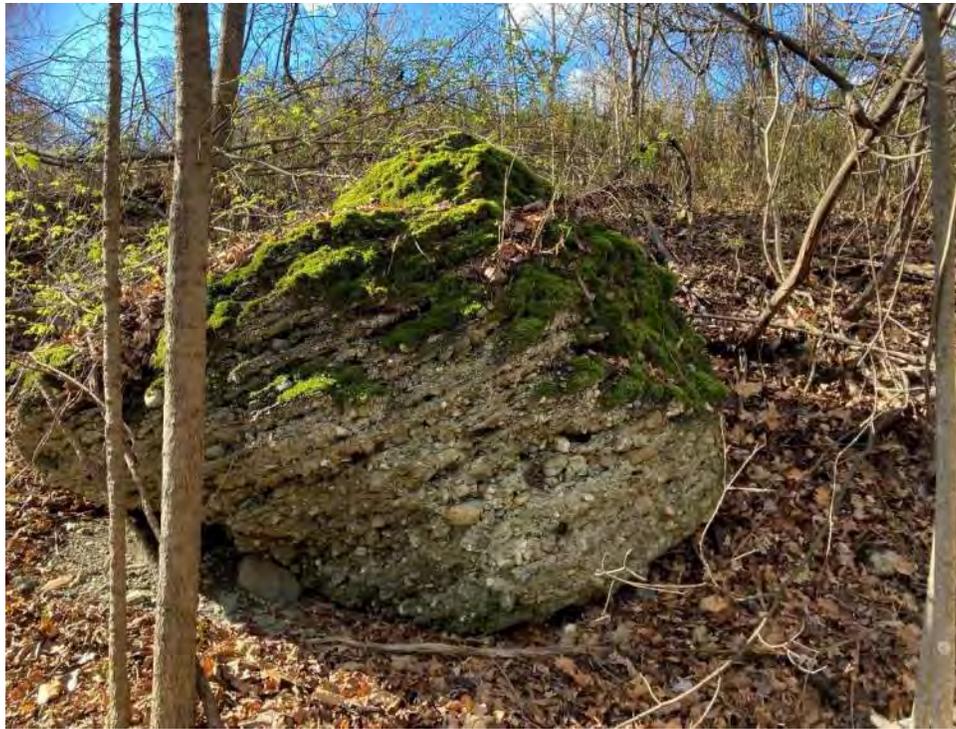
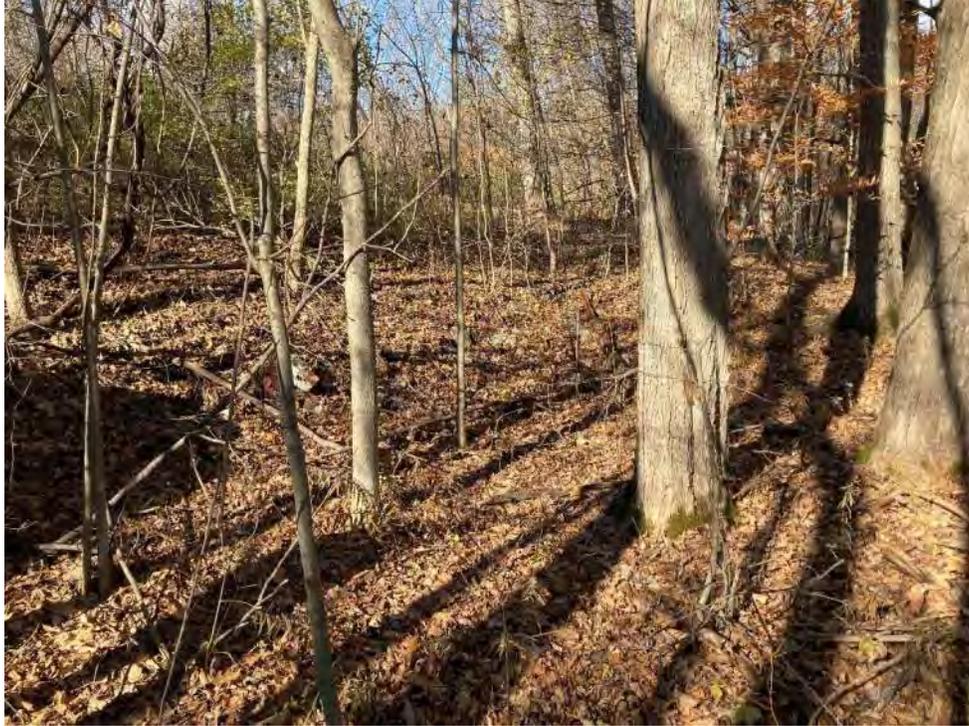
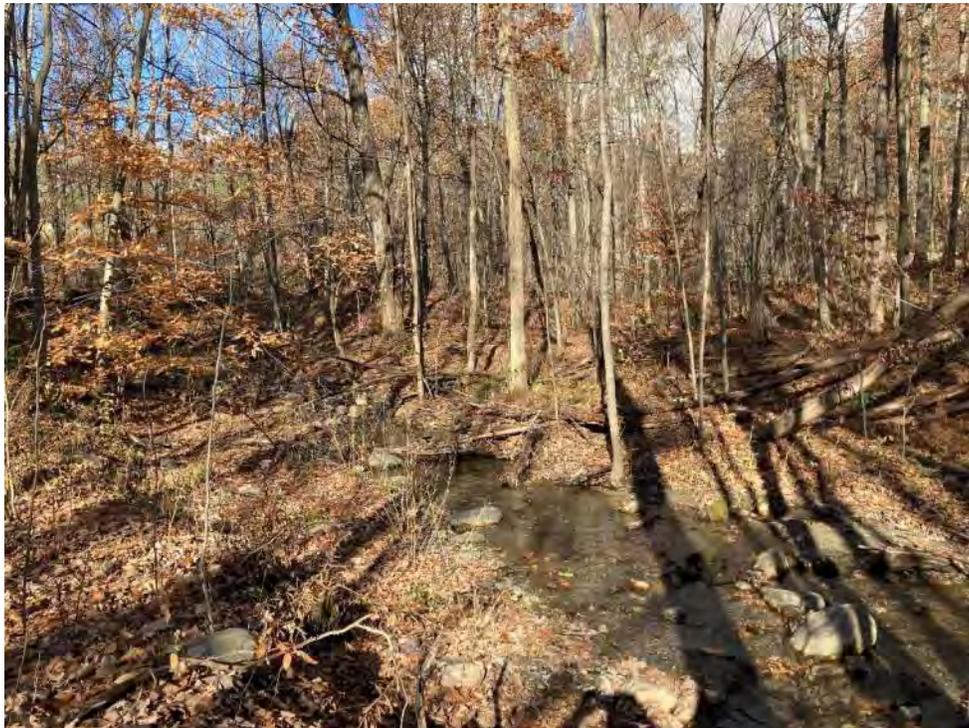
Figure 25. View west within the easternmost end of the project area near the stream and Staso Road, at the former landfill location.

Figure 26. View of large concrete mass within the easternmost end of the project area near the stream and Staso Road, at the former landfill location.

Figure 27. View north at the easternmost end of the project area near the stream and Staso Road, at the former landfill location; note machinery part in the ground behind small tree at left.

Figure 28. View northwest of the stream in the easternmost end of the project area, adjacent to Staso Road (at background right).

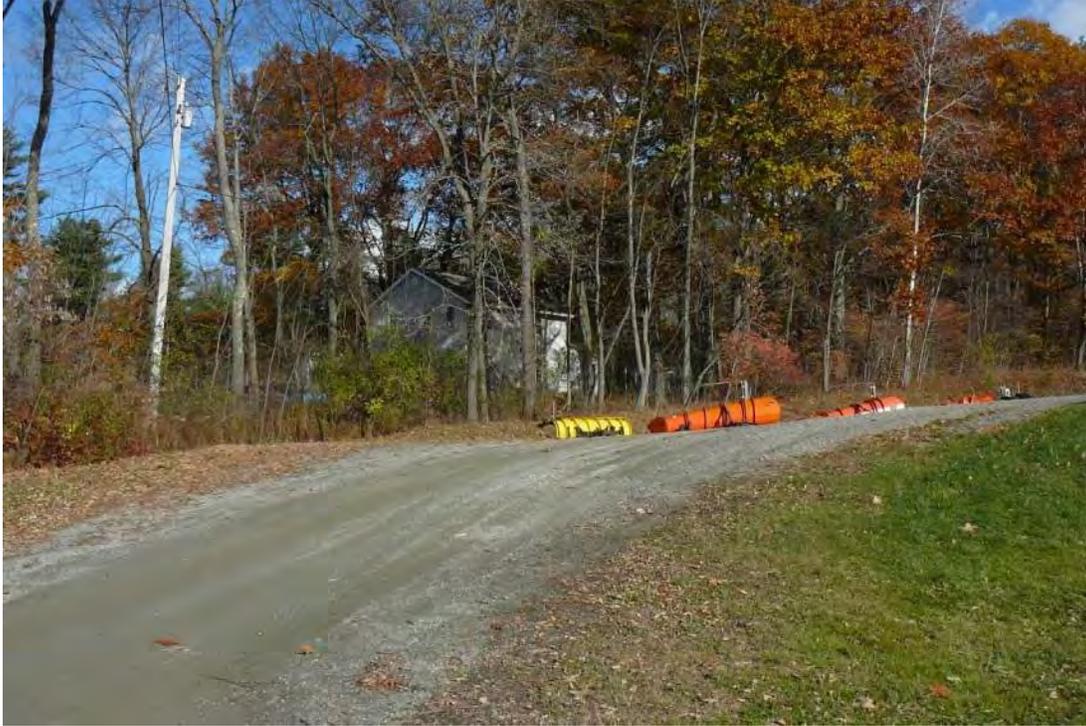
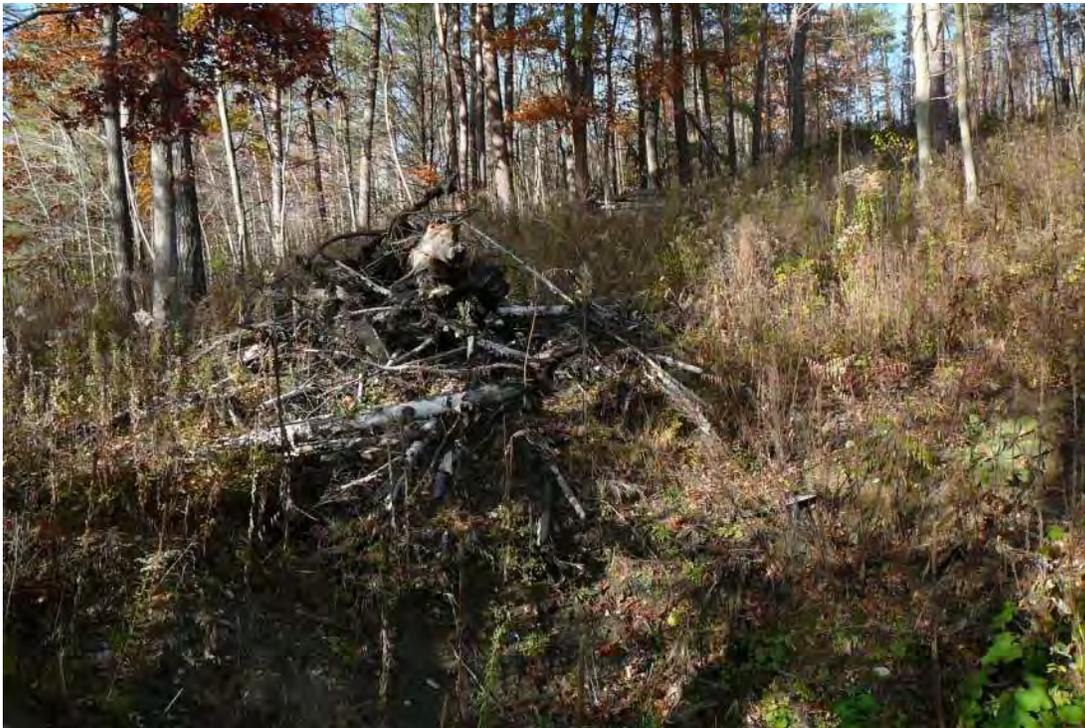
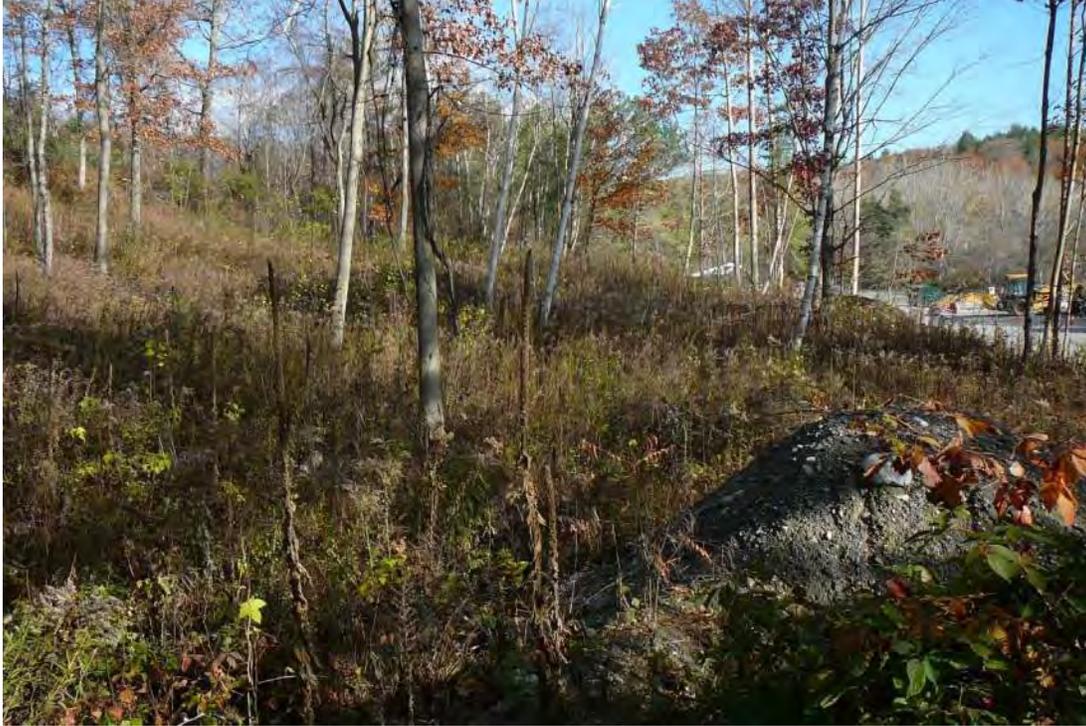
Figure 29. View northeast of a potential location for a salt shed at the western end of the project area, west of the highway department buildings.

Figure 30. View northwest of a potential location for a salt shed at the western end of the project area, east of the highway department buildings.

Figure 31. View southeast of a potential location for a salt shed at the western end of the project area, east of the highway department buildings.

The field inspection also confirmed that the two areas currently identified as possible new salt shed locations are not sensitive (see Figure 3). The location at the very western end of the project area, to the west of the highway department garages, is on a paved surface that appears to have been leveled (Figure 29). The location to the east of the highway department buildings is a steep slope, that also appears to have been disturbed by earth movement (Figures 30 and 31).
