# Stormwater Scoping Study

## Castleton | Staso Road

Castleton TAP TA 19(3) Staso Road Stormwater Scoping Study

MSK Engineers

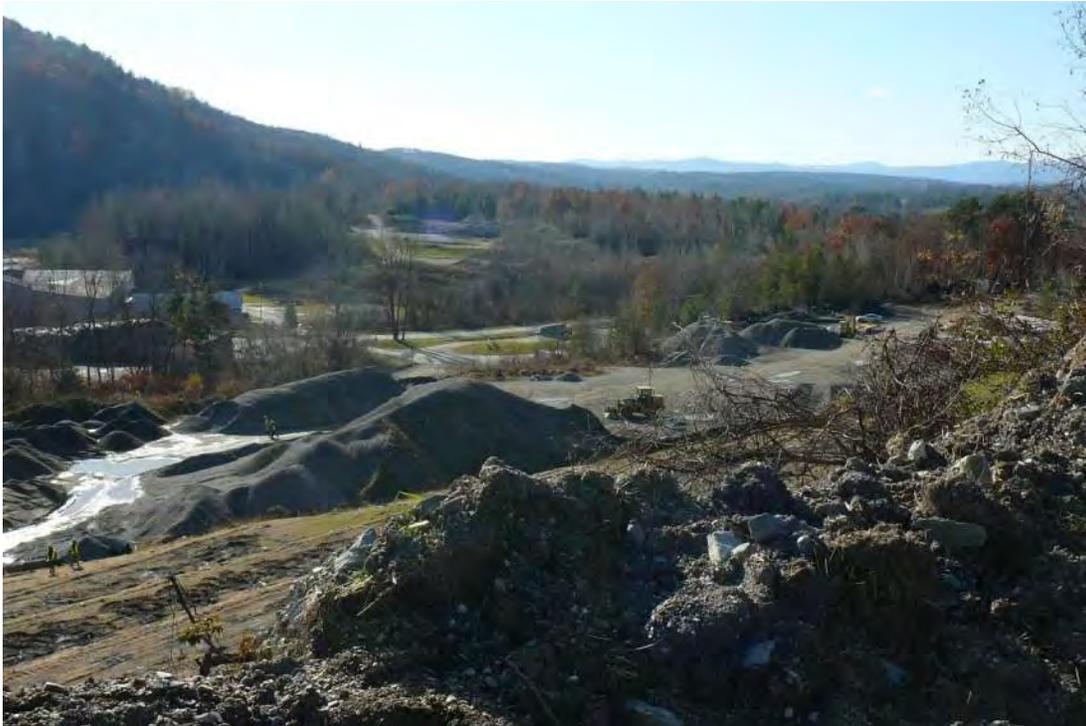
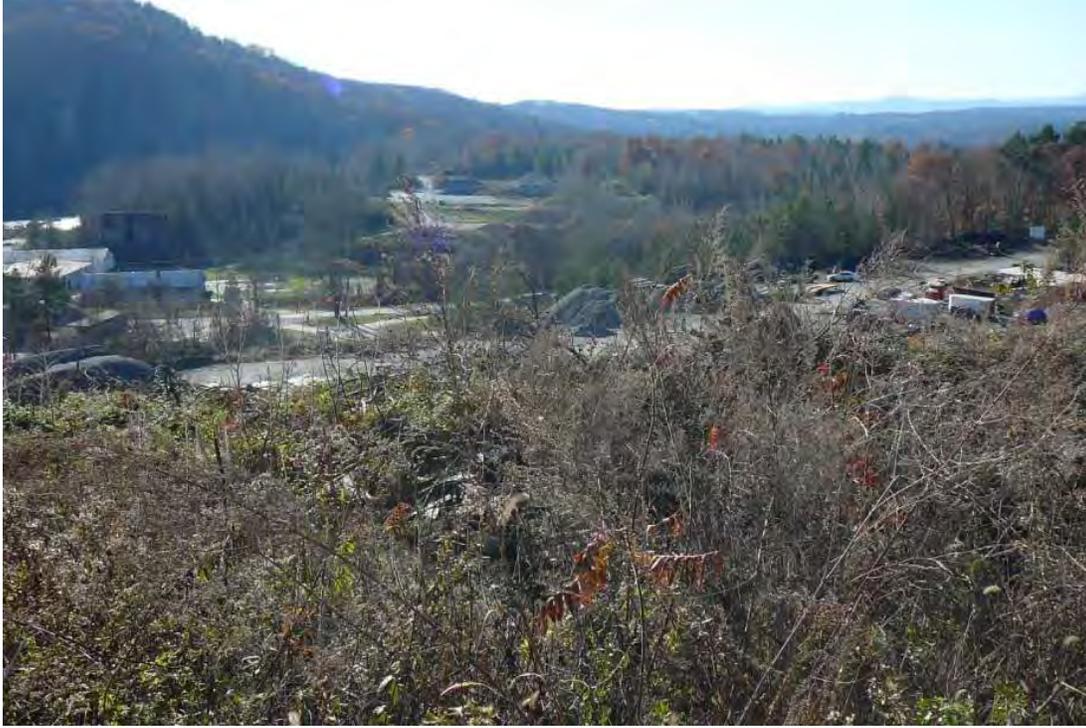
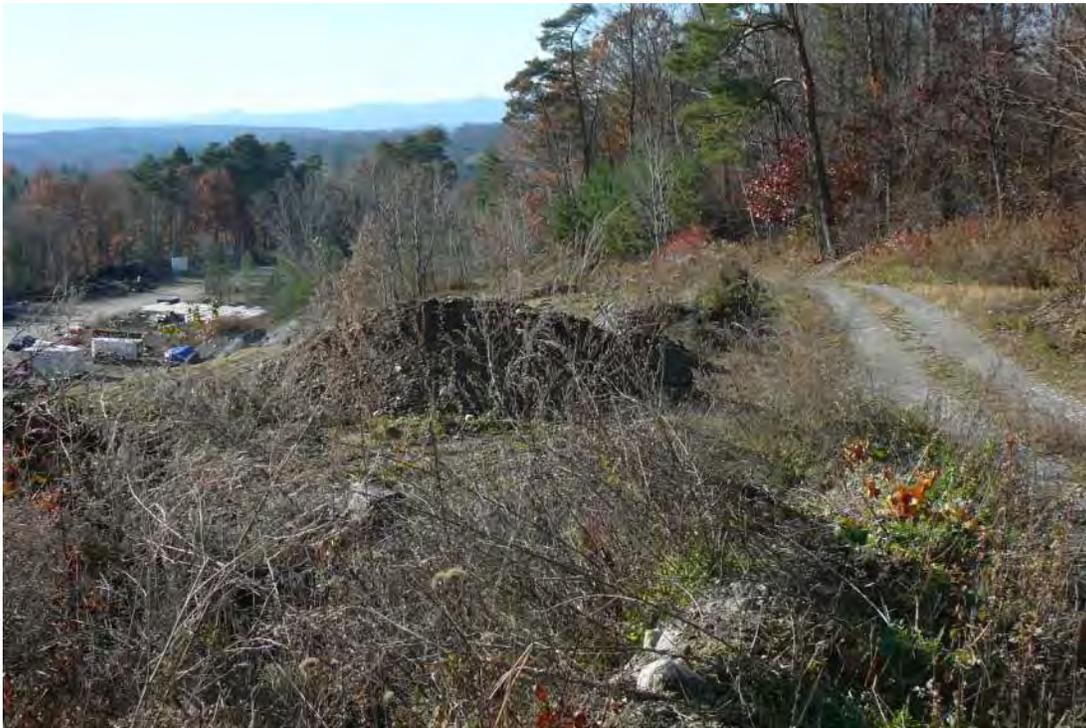
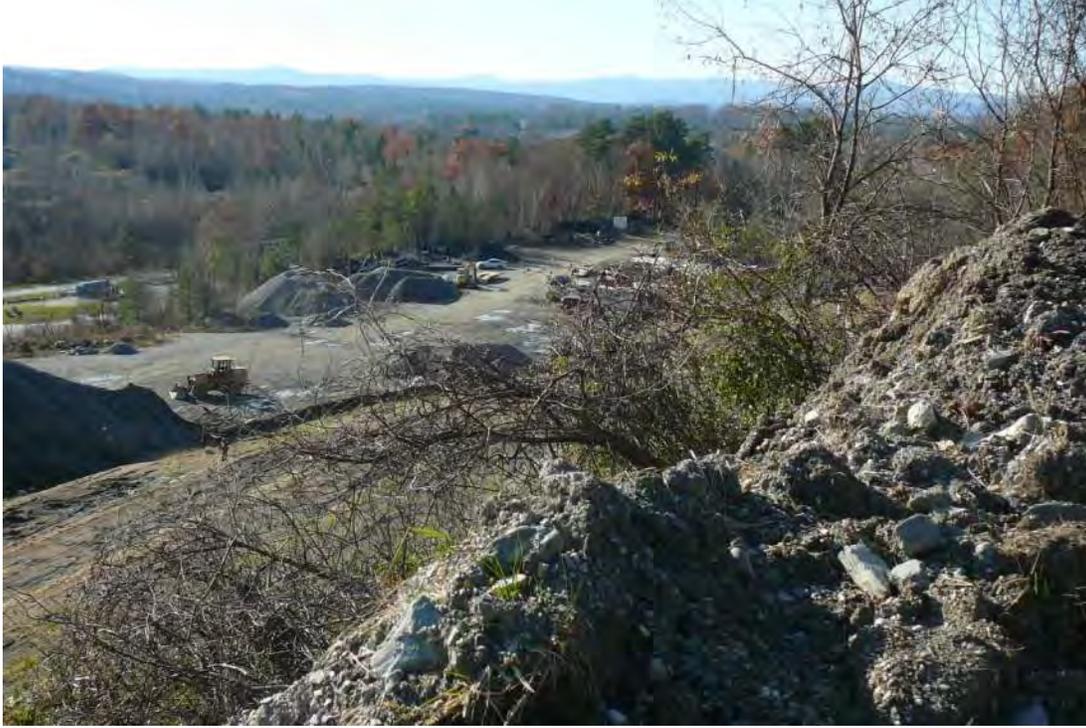
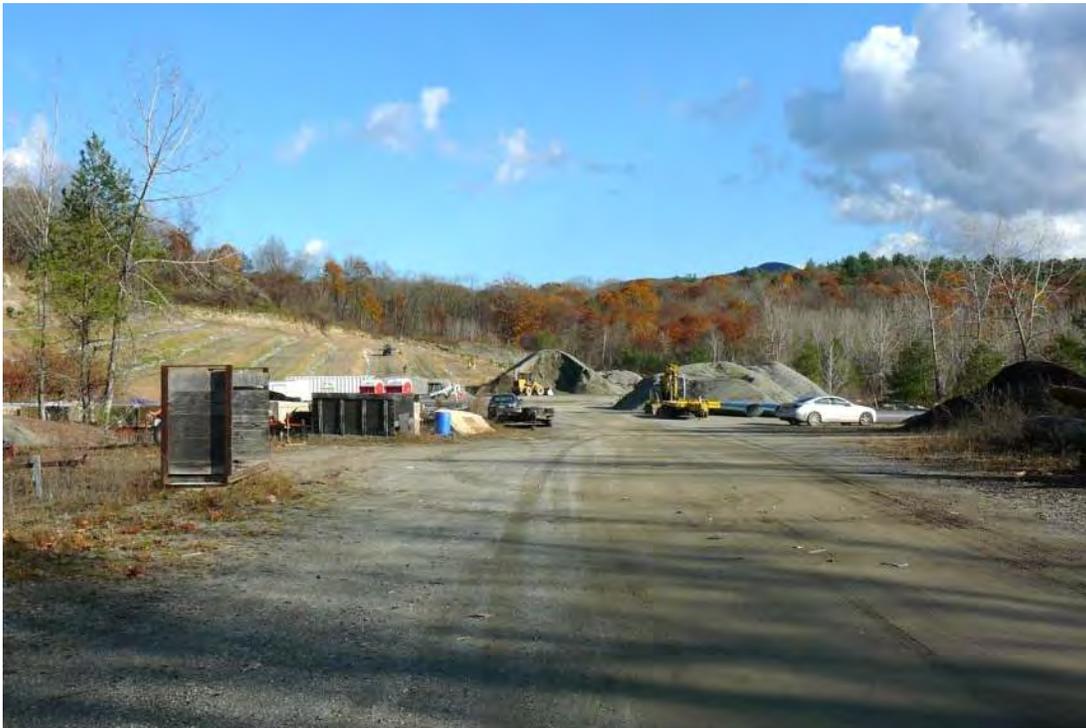
Figure 32. View southwest over the project area from the quarry edge.

Figure 33. View southwest over the project area from the quarry edge.

Figure 34. View west over the project area from the quarry edge.

Figure 35. View southwest over the project area from the quarry edge.

Figure 36. View east into the quarry pit at the solar installation location.

The vast majority of the remainder the project area has been significantly disturbed by past and current quarrying activity, and no additional areas sensitive for pre-Contact Native American sites were identified during the field inspection (Figures 32 – 36).
